PRELIMINARY ARBORICULTURAL & VEGETATION ASSESSMENT – TEITEI DRIVE BLOCK, OHAKUNE

PREPARED FOR: Kainga Ora – attn: Fletcher Wilson
BY: Richard Peers
DATE: 5 March 2023

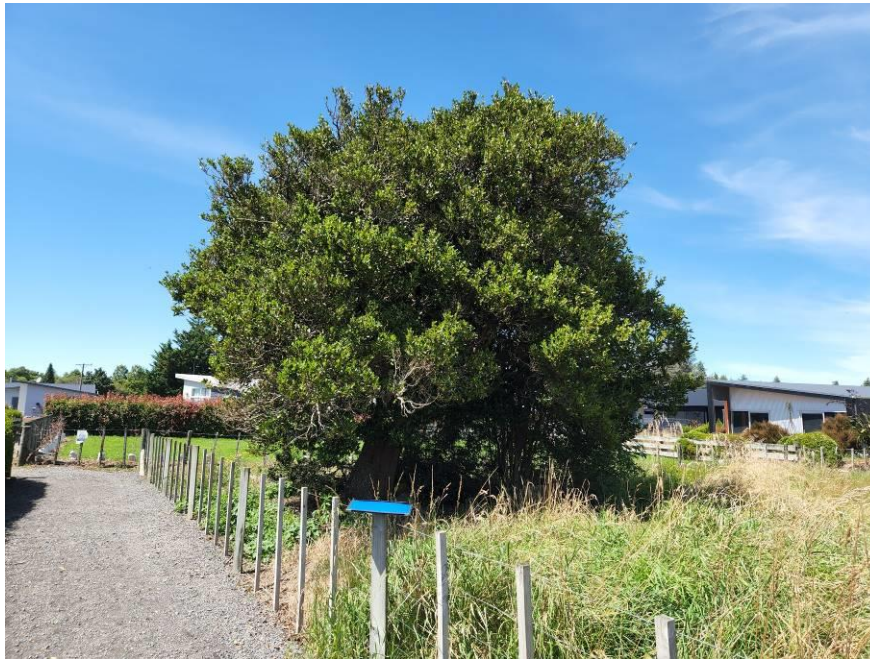
This area is actually one feature tree with some under-storey weed vegetation under its canopy. The tree is a veteran mature Kapuka (*Griselinia littoralis*) that is in a good state of health. It has a particularly stout trunk which carries a dense and compact crown. Given its size and veteran status, I suspect it may be a remnant of original native bush that once covered the area.

Image 1 – Kapuka, as viewed from west

1. Consider retention of Kapuka as a feature. Canopy can be pruned to remove dead wood and attain a balanced appearance
2. Remove the Elderberry and Cotoneaster. Treat stumps with herbicide – do not grind or extract by machine

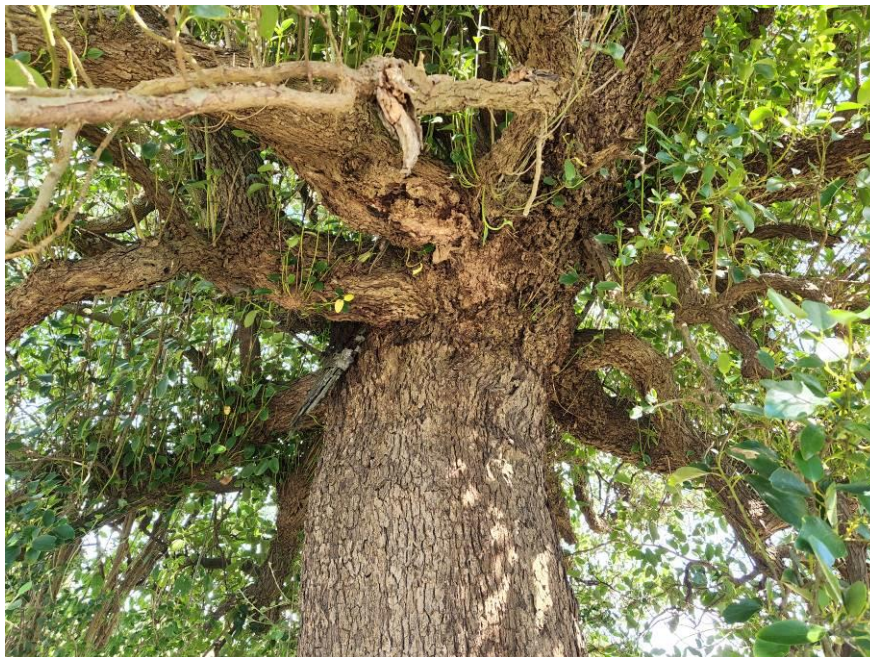
Image 2 – close-up of trunk and scaffold system

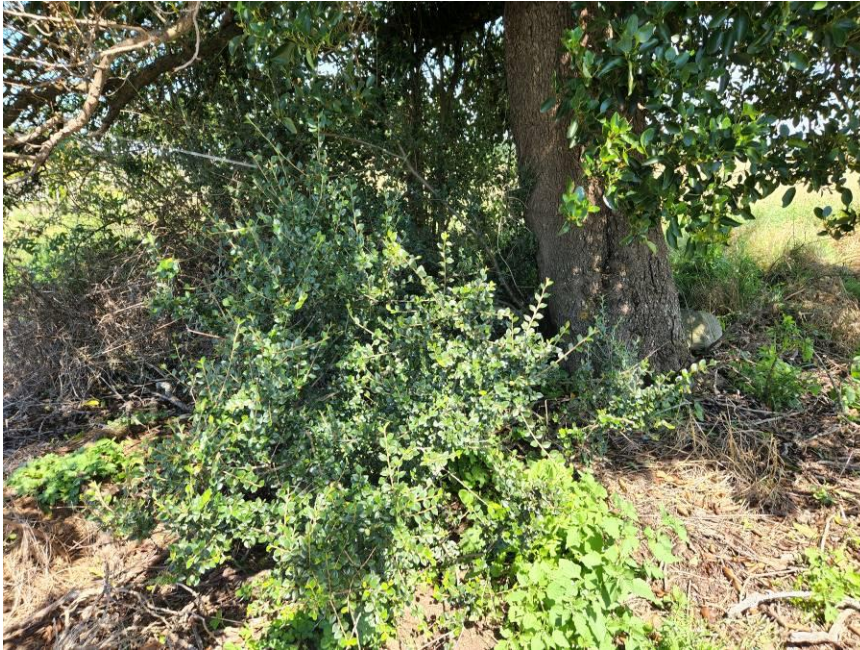
The weeds are two Elderberry (*Sambuca nigra*) bushes and one Cotoneaster bush. They are growing up into the crown of the Kapuka.

Image 3 – showing elderberry and Cotoneaster weeds

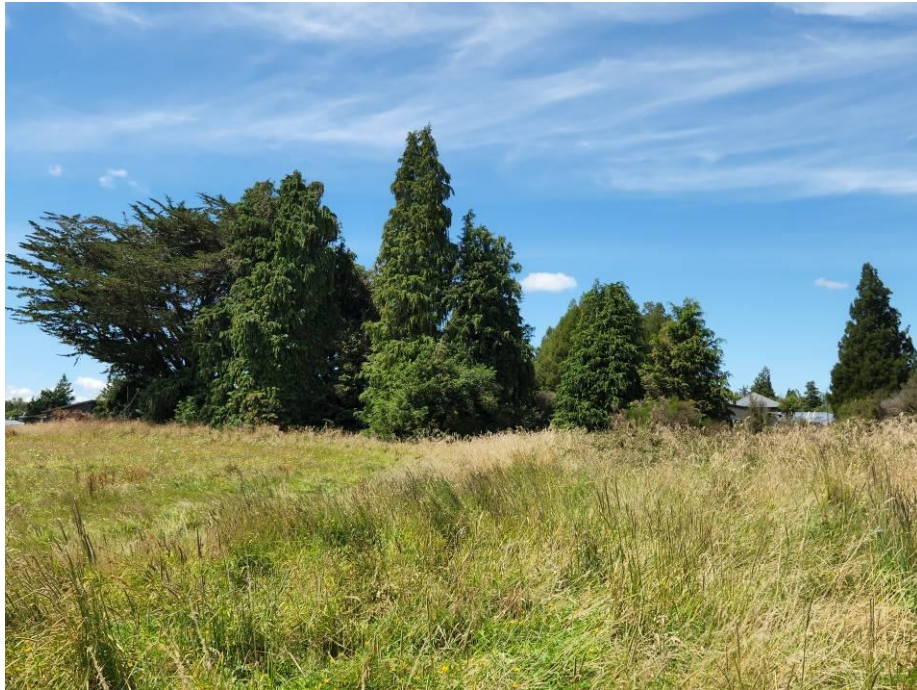
Image 4 – Area 1, as viewed from west

- Remove macrocarpa and Lawson cypress trees
- Remove all weed species and cut and fallen material
- Consider retention of Kahikatea

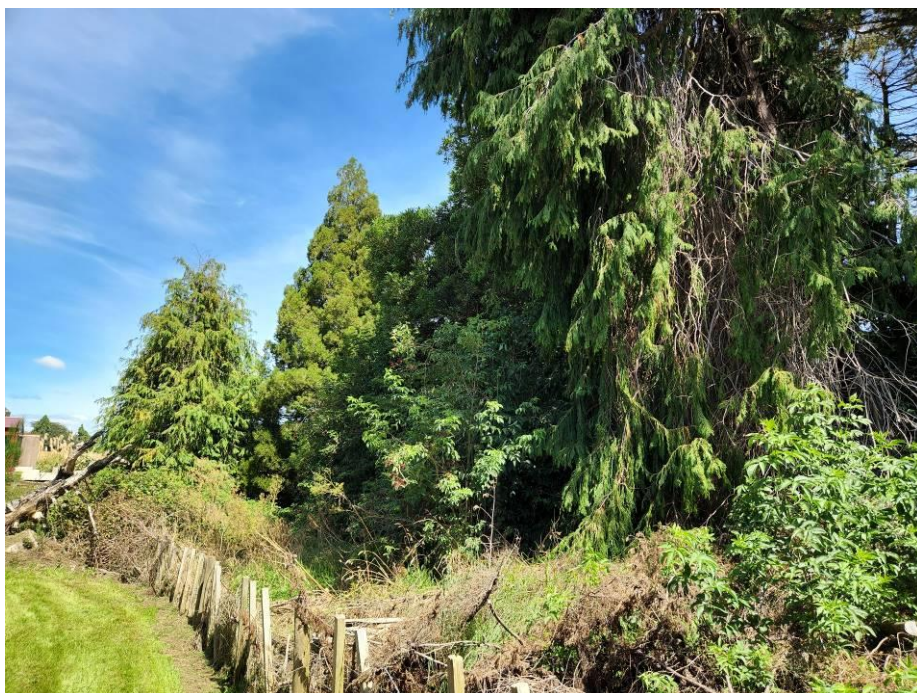
Image 5 – as viewed from yard of neighbouring property

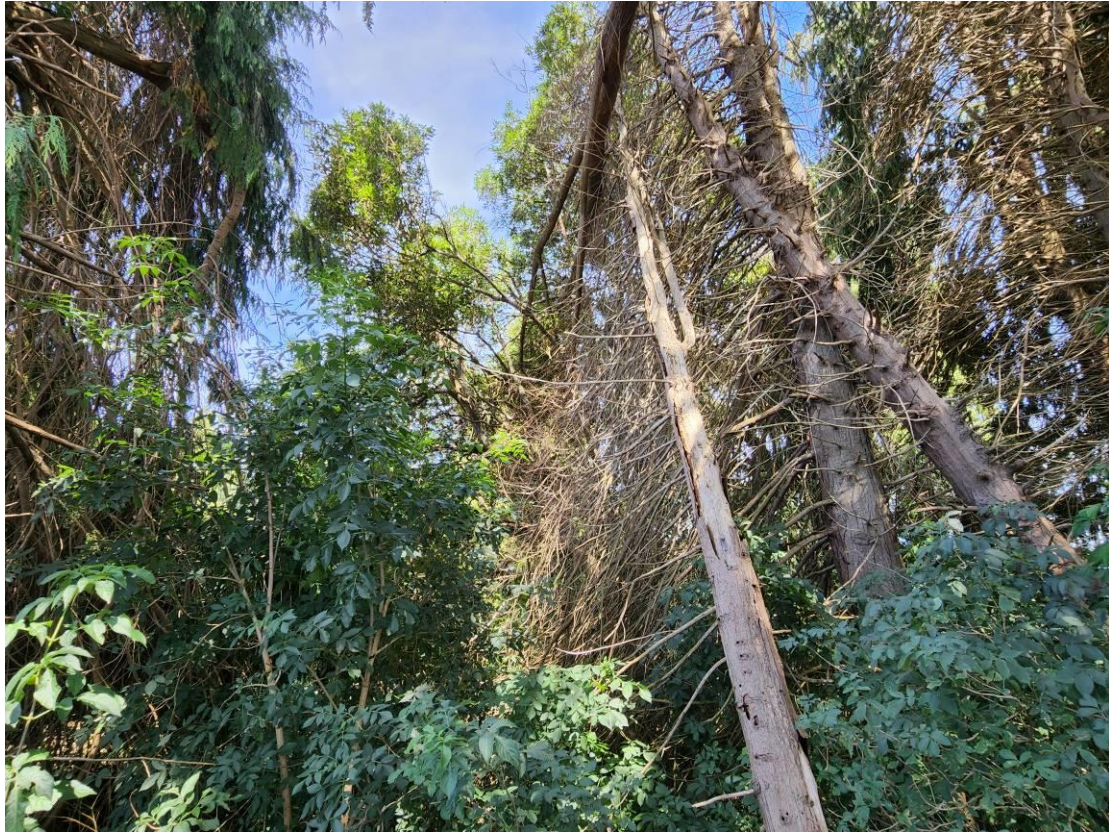
The weed species comprise, for the most part, a dense mass of elderberry throughout the stand of trees. There are also dense areas of blackberry at the perimeter of the stand.

Image 6 – interior view of Lawson cypress and elderberry

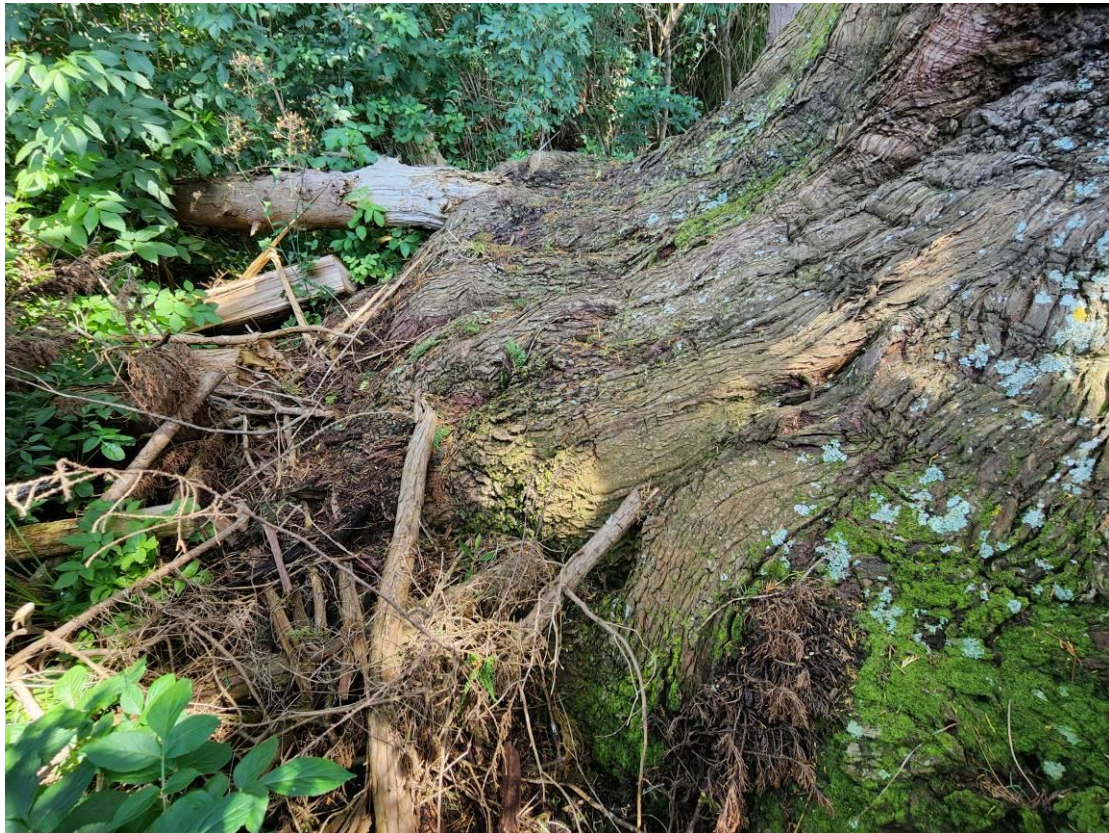
- One over-mature (senescent) *Cupressus macrocarpa* that has been lopped and which displays sites of large limb failures. It has an unusually prominent above-ground buttress root plate
- Several *Chamaecyparis lawsoniana* (Lawson cypress). These range from full-crowned mature specimens through to dead specimens. Some dead trees have fallen and are hung-up against adjacent trees. One has been lopped from a neighbouring property. Many have deep-seated stem decay
- 1 x semi-mature Kahikatea tree stands beside a ditch. It is in a good state of health and is structurally sound
- 1 x Black Maire (*Nestegis cunninghamii*). This is a semi-mature native specimen in a good state of health that is crowded by adjacent trees. It is the source of several seedlings

Image 7 – buttress root plate of macrocarpa

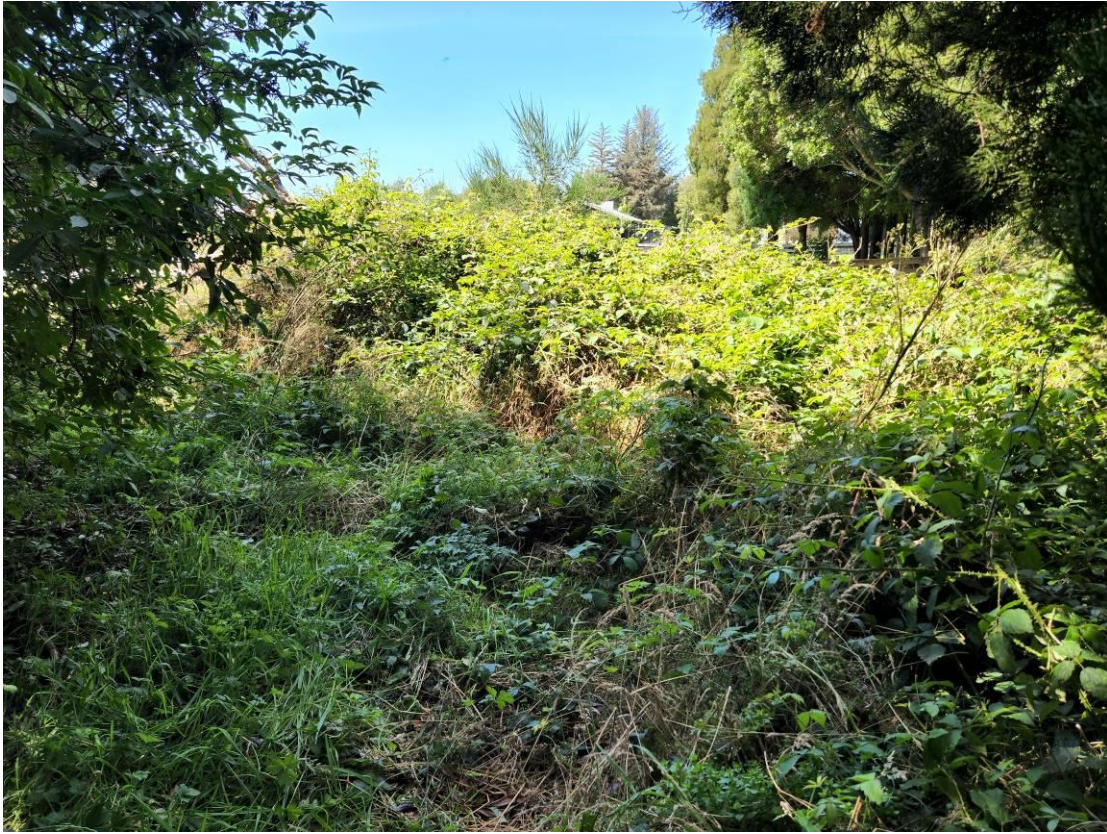
Image 8 – Blackberry against boundary

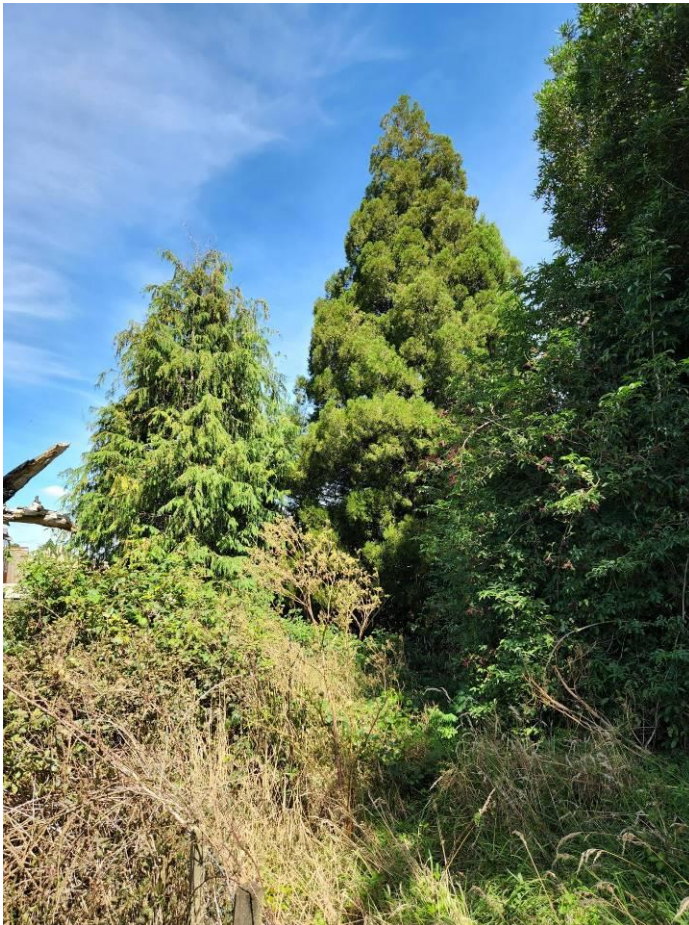
Image 9 – Kahikatea in centre

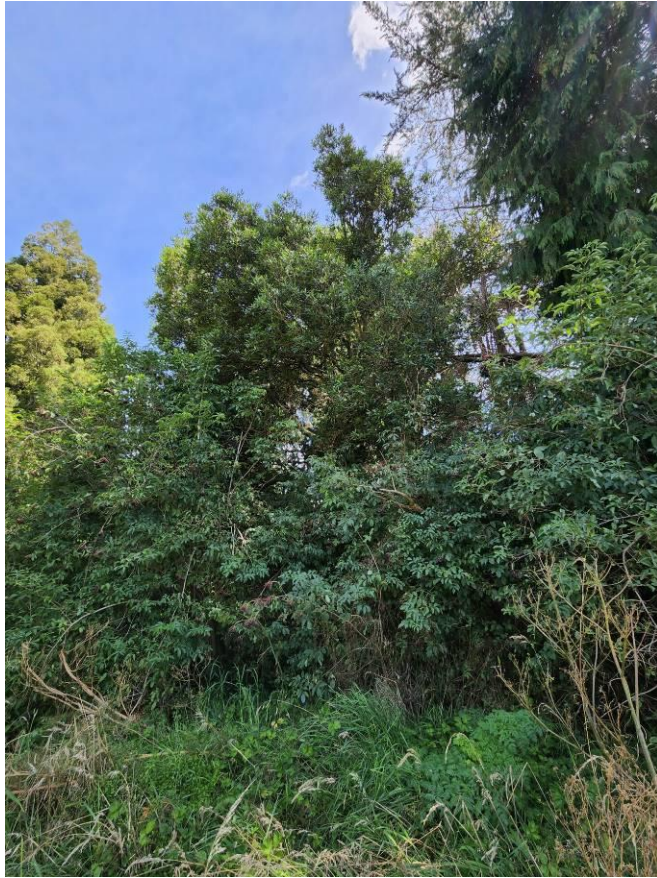
Image 10 – Crown of Maire in centre. Kahikatea to left

- Consider retention of Black Maire. However, when surrounding trees are removed, an arborist should assess the structural condition of its trunk, as included unions were observed but were not able to be closely inspected due to the crowding from adjacent trees and vegetation
- Offer Maire seedlings to a local native plant nursery to uplift

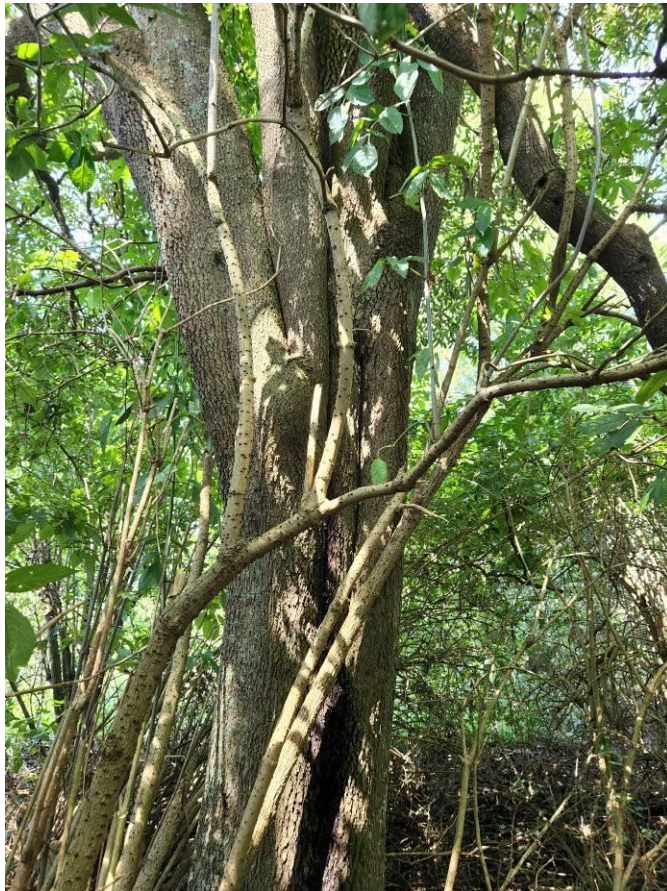
Image 11 – closer view of trunk formation of Maire

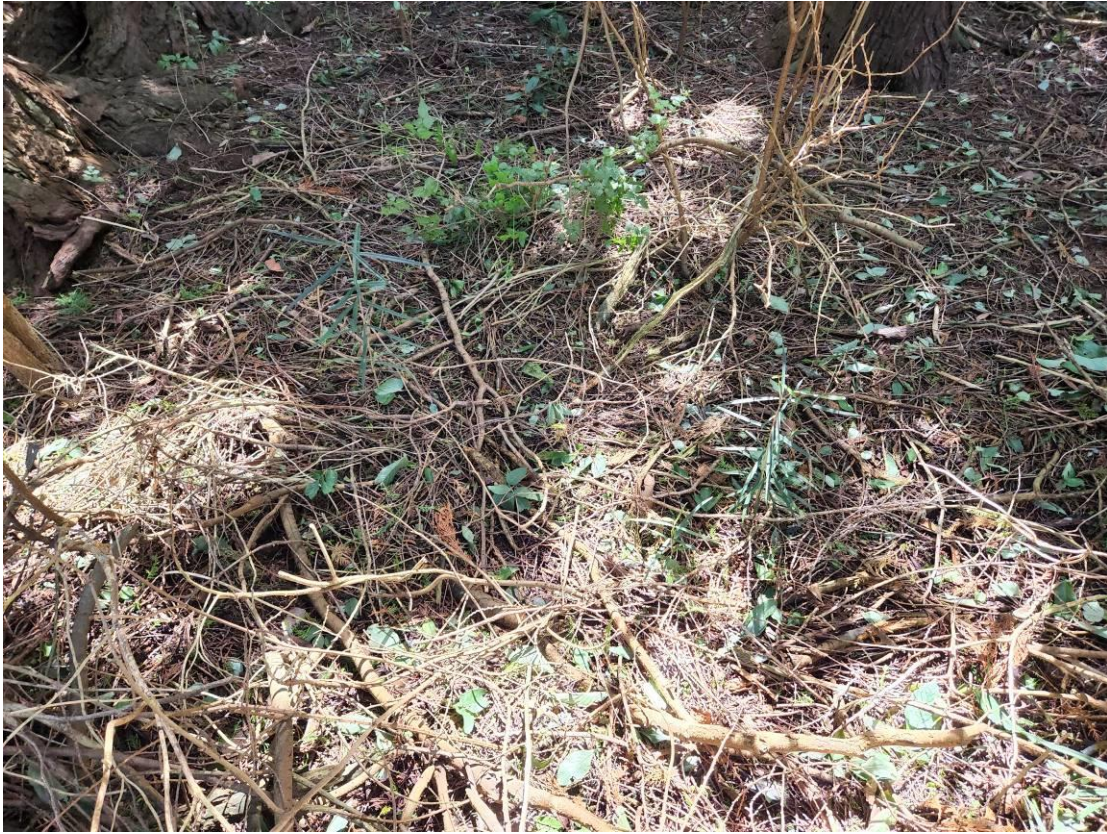
Image 12 – Maire seedlings

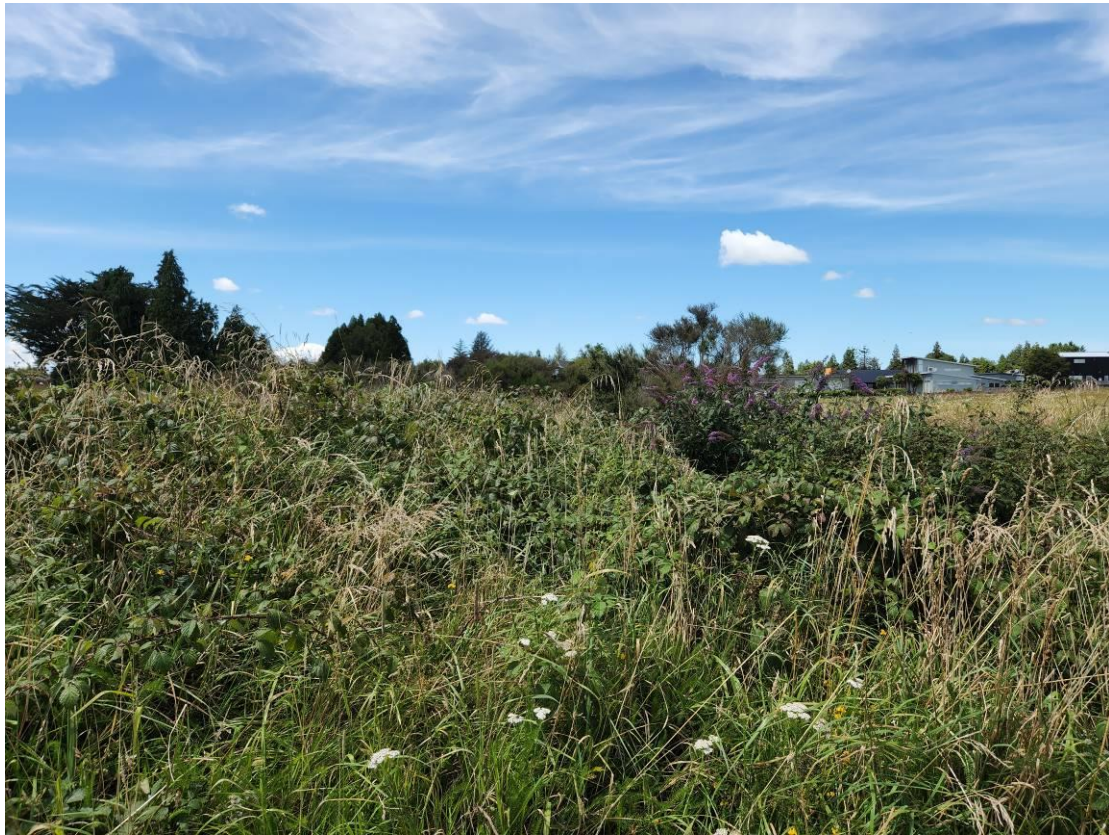
This area is essentially a wetland linked to a ditch that contains, but not limited to, the following;

Image 13 – Area 3, as viewed from south

- Investigate whether this area meets the standards whereby it can be defined as a ‘wetland’ and whether there are any statutory protection mechanisms over such a natural environment
- Weeds should be eradicated at the least
- Manuka seems to be concentrated at the edges of the ditch, so maybe able to be retained if ditch is maintained as a water course – possibly with riparian planting carried out

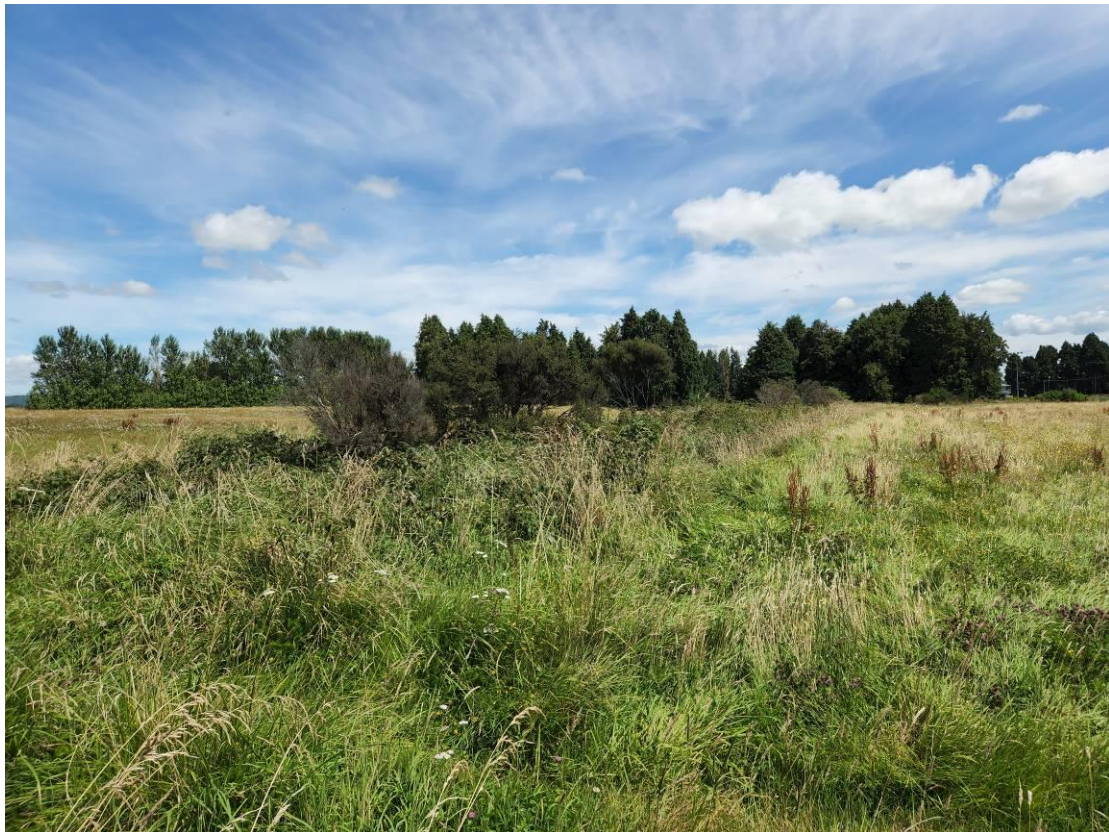
Image 14 – looking southwards. Note Manuka near ditch

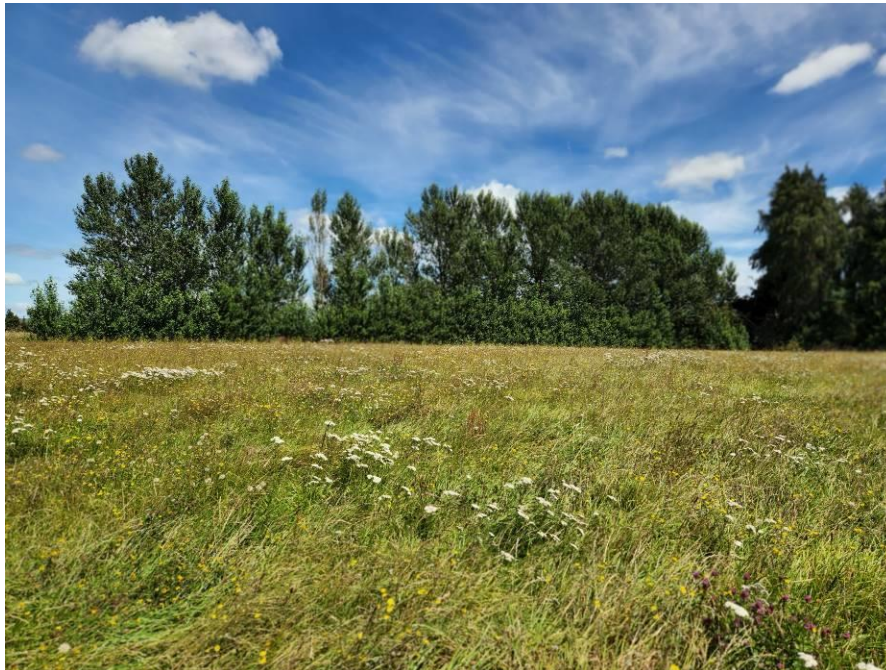
This area encompasses a mass of poplar suckers that run adjacent to a section of the southern boundary. These suckers emanate from a line of hybrid poplar trees in the neighbouring property that have been planted adjacent to the boundary fence. Within the subject site there is an approximately 3m width strip of suckers adjacent to the fence which have been allowed to grow on. Beyond this strip there is a profusion of lower suckers in the paddock – extending out to several metres in some places. It seems that the paddock has been mowed – leaving the 3m strip unmowed.

This root suckering from the poplars in the neighbouring property is potentially problematic should residential housing be planned for this area of the site. These trees are clearly very invasive.

Image 15 – the line of poplar trees. Note the two tiers – the lower being sucker growth within the site

- The suckering root mass from these trees must be physically removed if there is to be residential housing – or any land use, for that matter, adjacent to this boundary. However, making such an excavation cut at the boundary line would potentially destabilise the parent trees in the neighbouring property; thereby creating a hazardous situation. Therefore....
- An approach should be made to the owner of the neighbouring property – with a proposition that the poplar trees should be removed

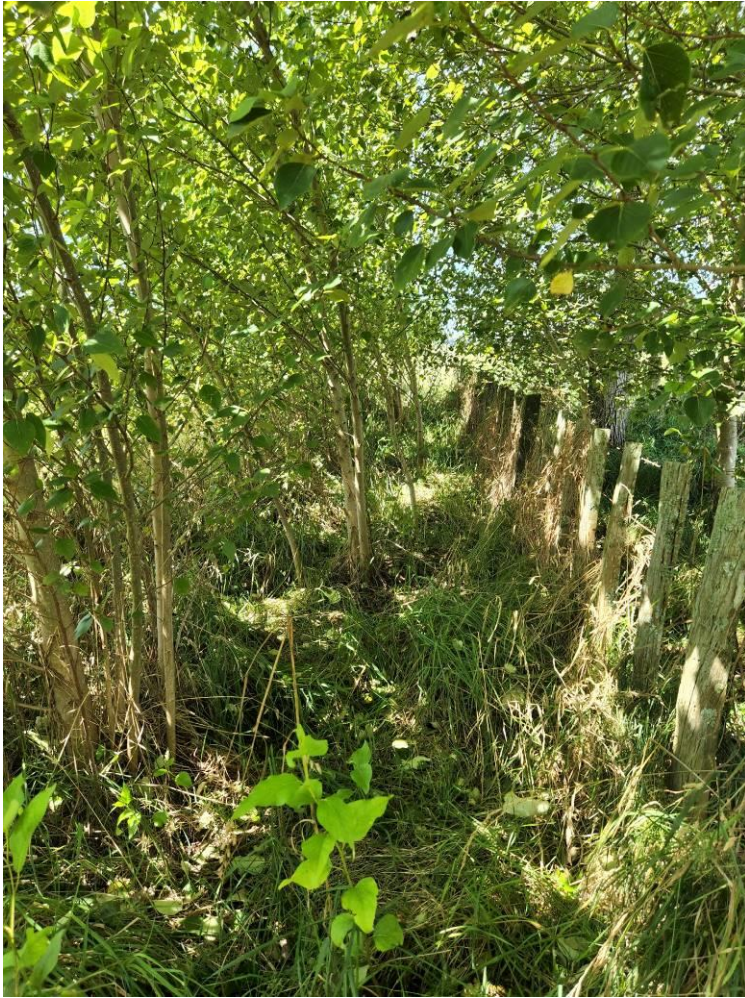
Image 16 – showing boundary fence – parent trees on right

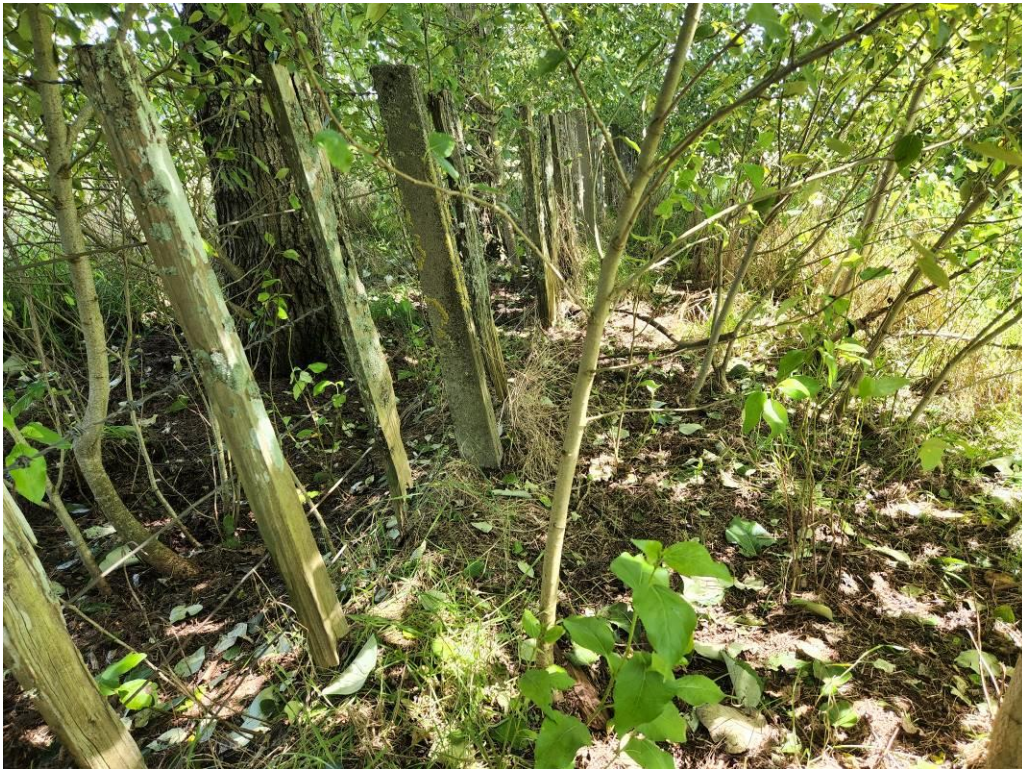
Image 17 – another view of the boundary fence with root suckers on the right

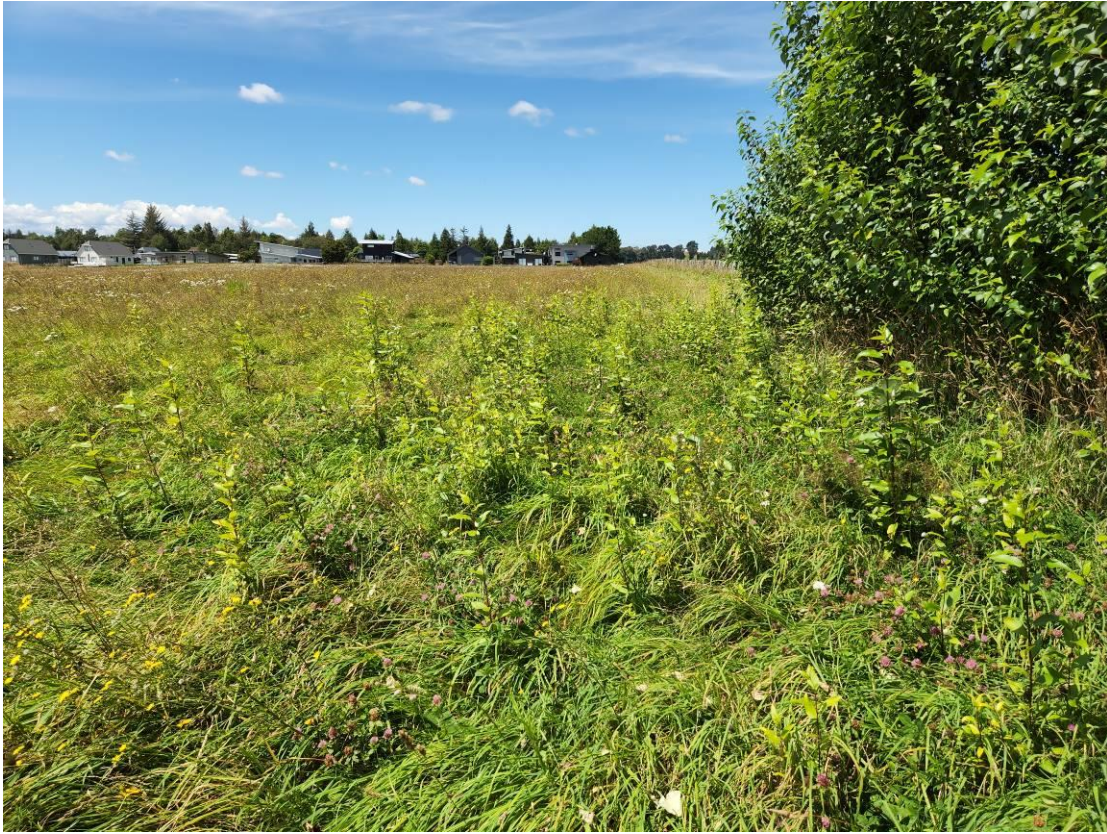
Image 18 – one view of the suckering extending far out into the paddock

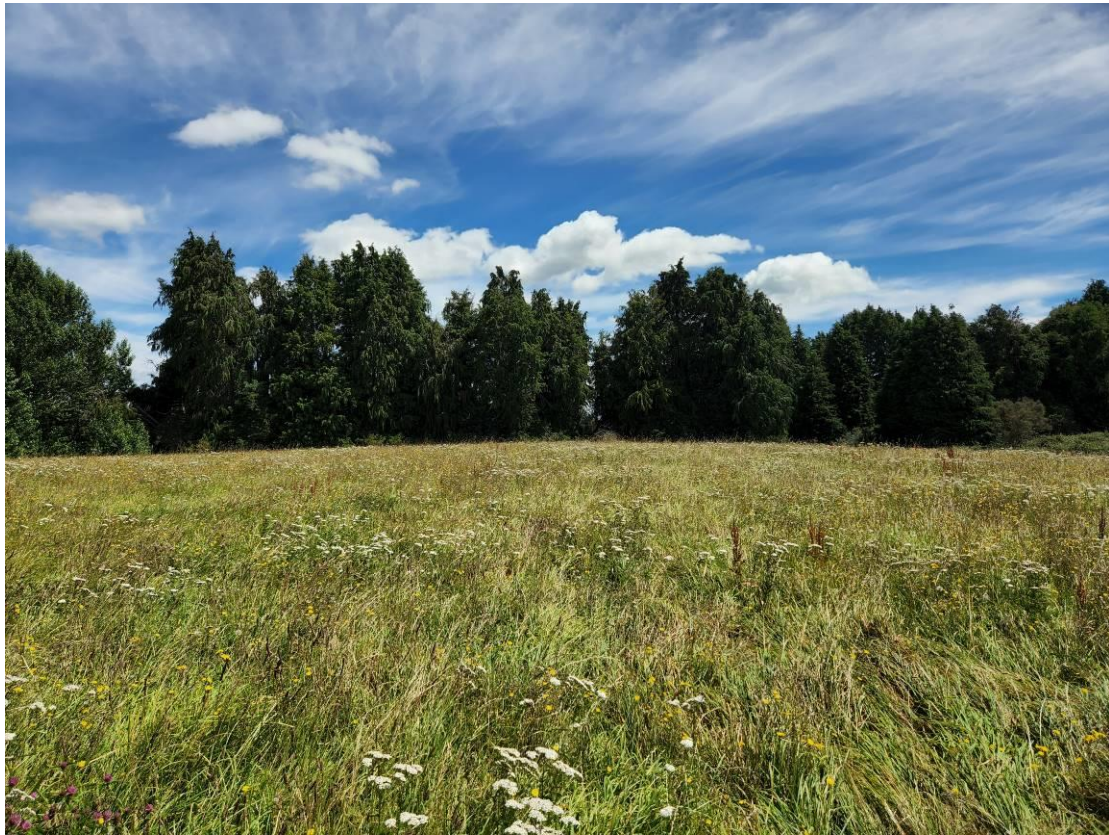
This area is a staggered line of Lawson cypress trees which extends along a section of the western boundary. It crosses the flowing water course which exits the property there. The trees are over-mature. A close inspection of them under their canopy reveals that most have extensive decay in and around the bases of their trunks. This most likely originates from historic stock damage to their root buttresses over many years and/or from horses having stripped the bark from the trunks, as they are wont to do with this species of tree – from experience. There are some fallen stems, due to the weakness inherent in the decay. This line of trees currently performs a useful function as a windbreak for the site – of winds from the south.

Image 19 – Area 5 as viewed from within site

- Serious consideration must be given to the safety rating of these Lawson cypress trees if residential housing is to be established in their vicinity/fall zone. Notwithstanding their poor structural condition, the trees are nearing the end of their useful life span in any case

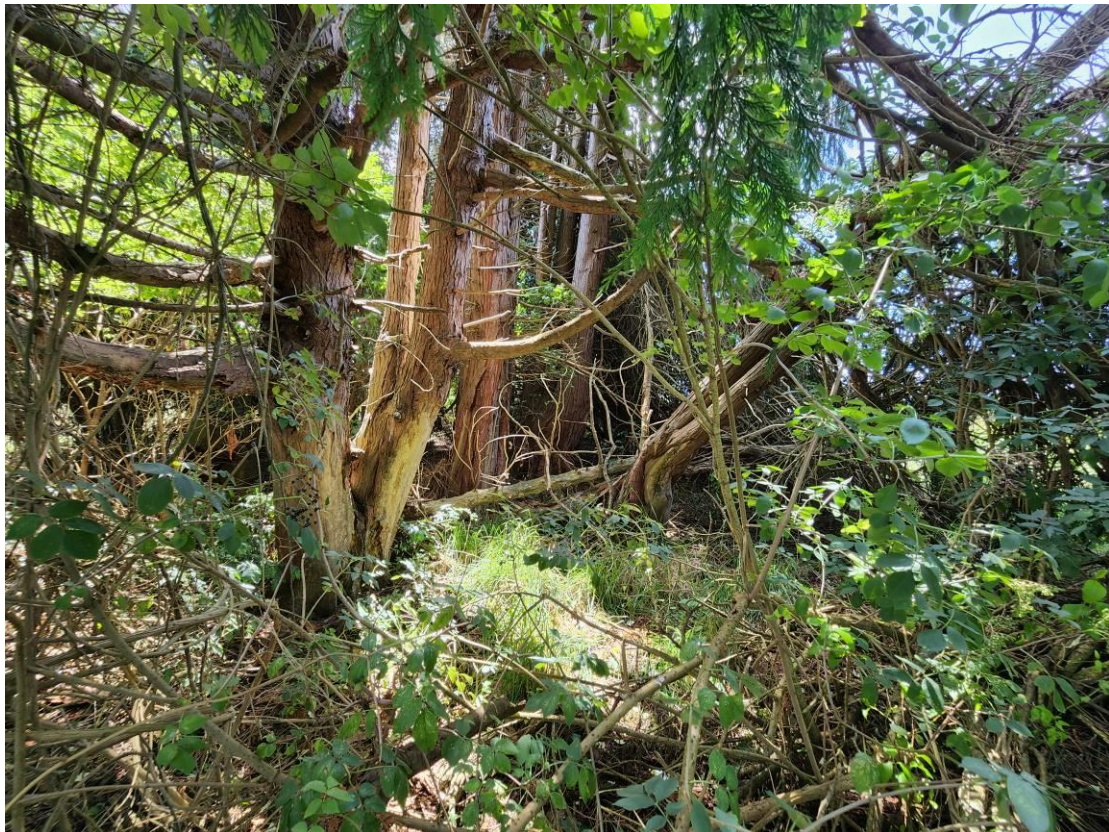
Image 19 – eastern end of Area 5. Note fallen stem

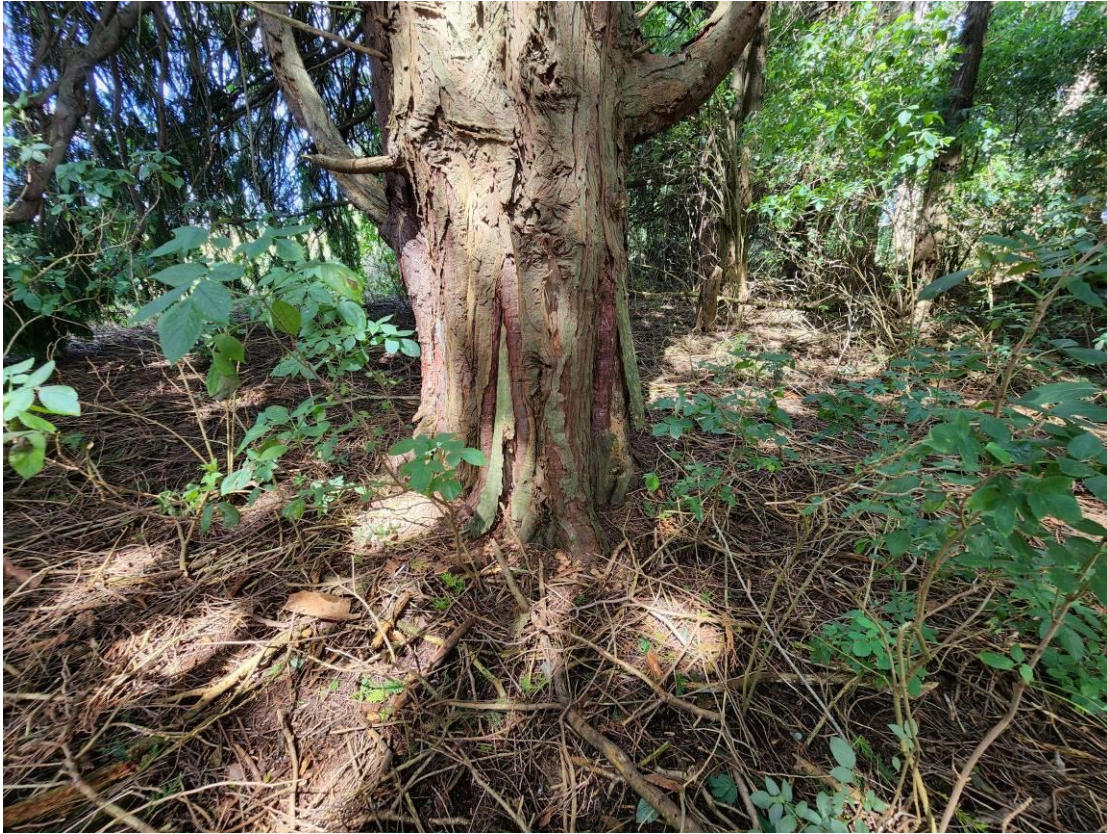
Image 20 – typical condition of tree trunks

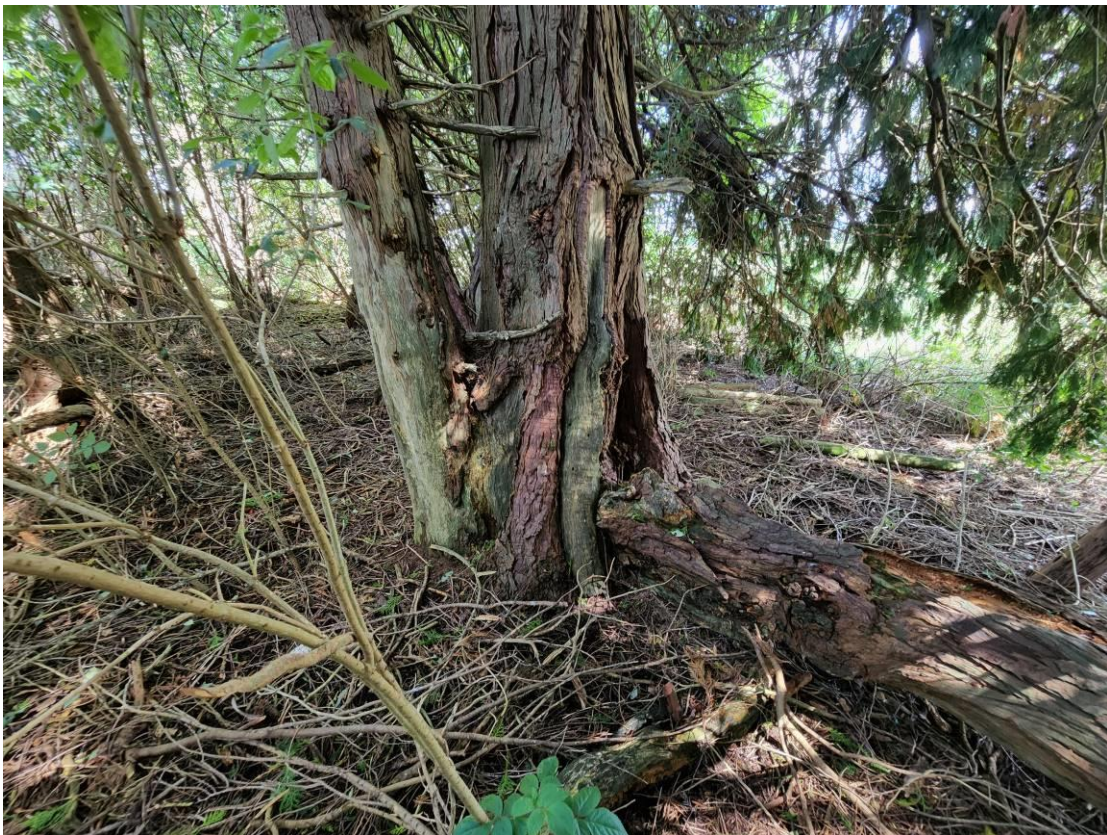
Image 21 – badly decayed trunk with split-out

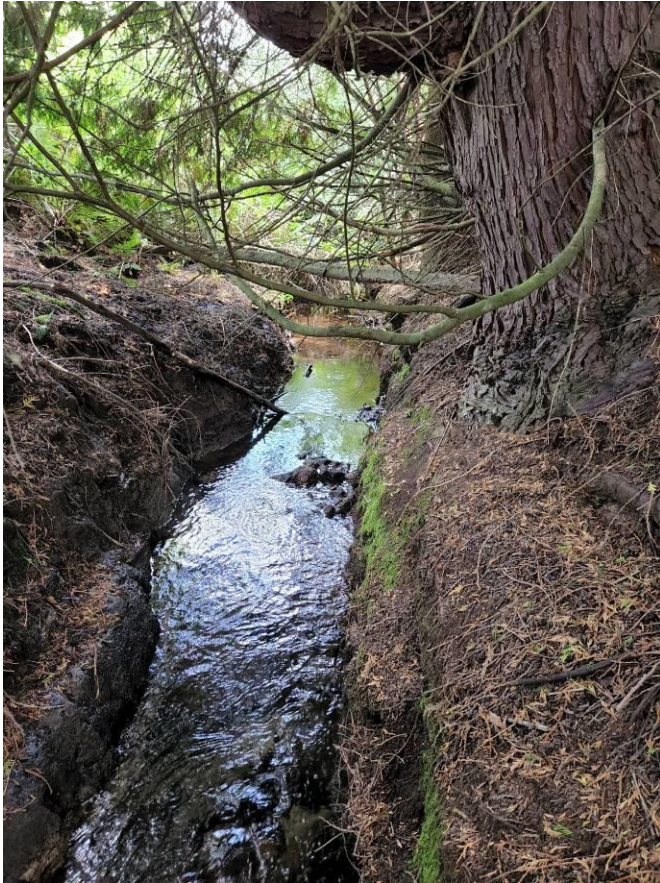
Image 22 – showing water course exiting site through Area 5

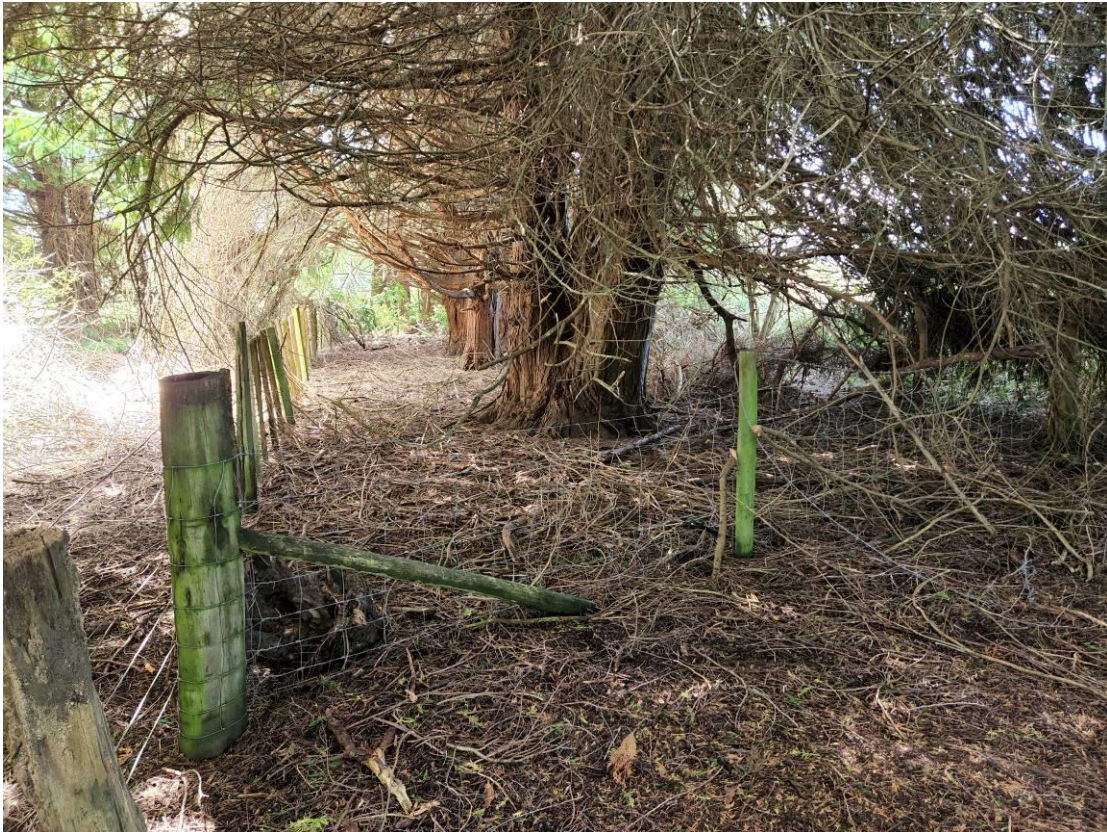
Image 23 – trees westwards of the water course

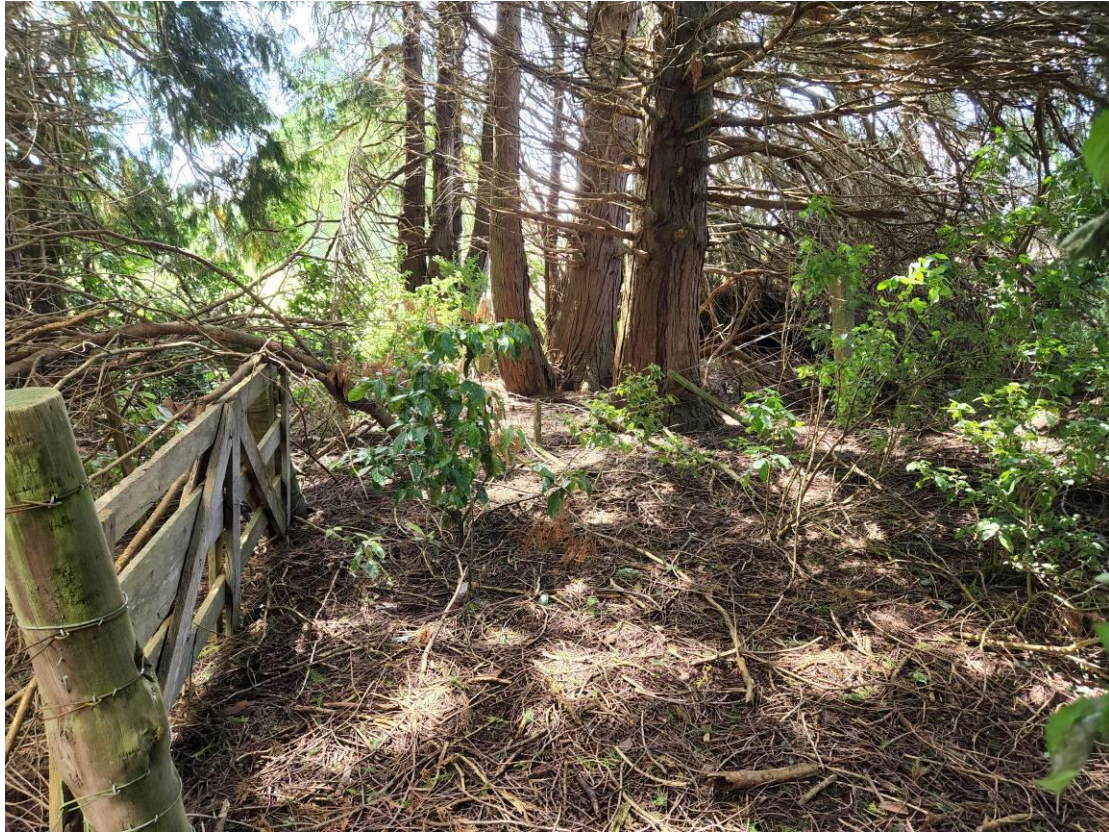
Image 24 – trees at western end of Area 5

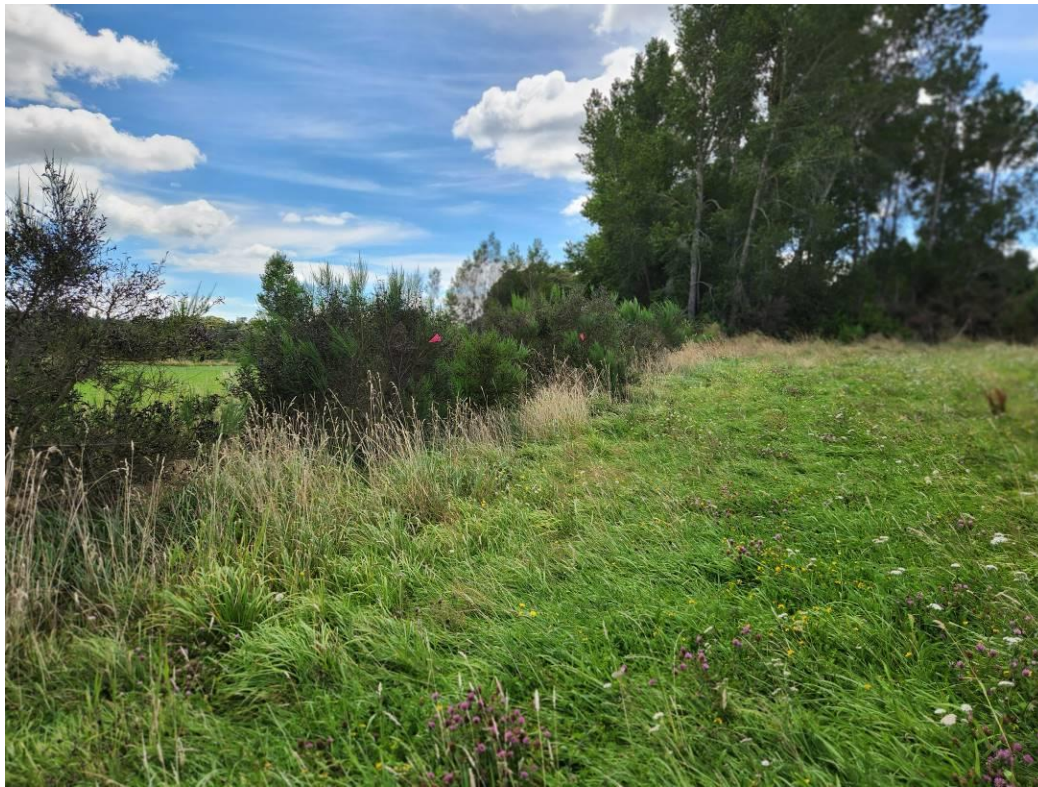
This area is a stand of closely-spaced, tall, lanky, drawn-up poplar trees in the northeast corner of the site. Some may stand in neighbouring properties to the west and north, and this will need to be ascertained. They appear to be in a good state of health and of generally sound structure. However, they tend to grow with a bias towards the east southeast.

Image 25 – stand of poplars in the distance. Note broom lining the ditch which runs alongside the southern boundary

- This stand of trees warrants closer inspection with a view to ascertaining (a) their stability in the ground, given their linkage to area 7, which is a wetland, (b) their vulnerability to windthrow should any surrounding vegetation be removed, (c) their general structural integrity and, (d) their ownership status. Dense thickets of weeds and other vegetation at their base makes it hard to inspect them thoroughly at this stage.
