PRELIMINARY ARBORICULTURAL & VEGETATION ASSESSMENT – TEITEI DRIVE BLOCK, OHAKUNE

PREPARED FOR: Kainga Ora – attn: Fletcher Wilson
BY: Richard Peers
DATE: 5 March 2023

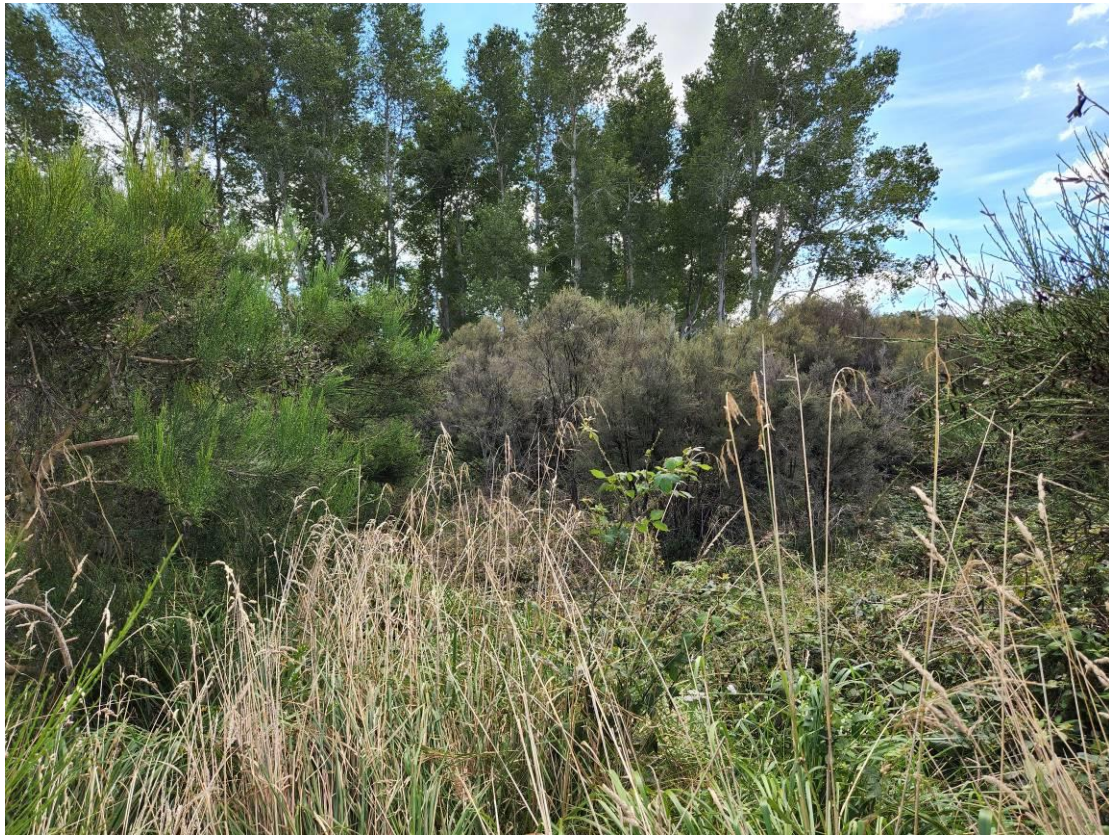
This area is essentially a very weed-infested impenetrable (on foot) wetland that may originally have been channelled as a ditch – but which is now a sprawling and irregularly-shaped wet ground area. The northern boundary line is not defined. The most prevalent weeds are broom, blackberry and Cotoneaster that, in most places, is smothered by a dense blanket of convulvulus. There is scrubby Manuka dispersed through some of the area. Towards the eastern end are self-propagating Crack willow and Pussy willow trees.

Image 26 – southern end of Area 7. Poplar trees are likely to be offsite

- Investigate whether this area meets the standards whereby it can be defined as a ‘wetland’ and whether there are any statutory protection mechanisms over such a natural environment
- Weeds should be eradicated at the least
- The area may be so degraded by the intensity of the weed infestation that it may need to be totally cleared and either channelled or restored to a native wetland environment. Such a decision should rightfully be made with the input of an ecologist, and in consultation with Council planners or environmental officers

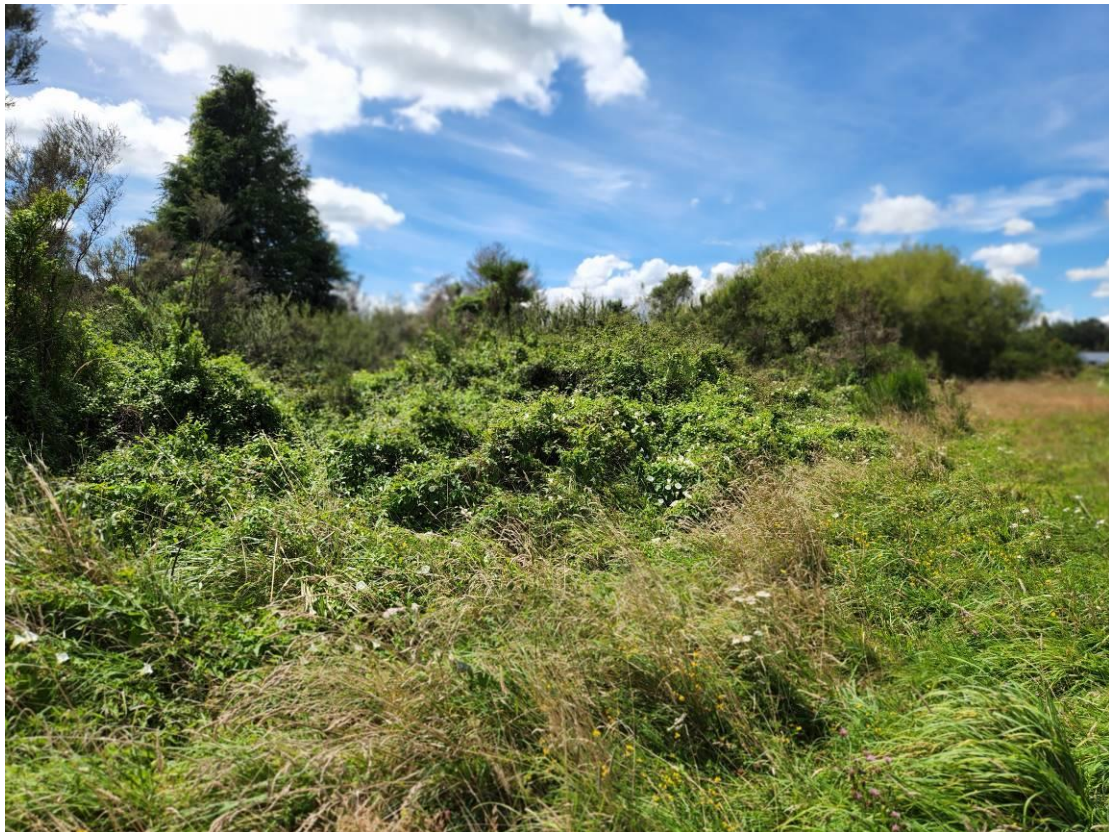
Image 27 – showing blanket of convolvulus

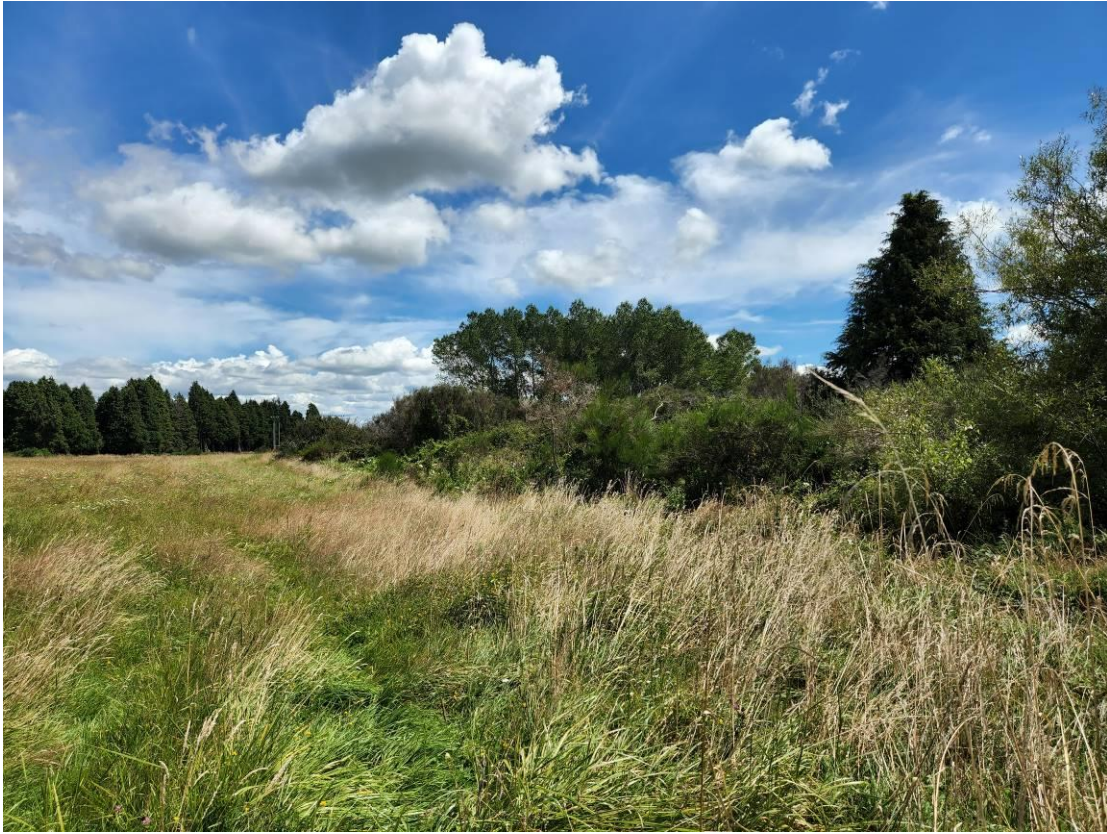
Image 28 – looking south. Tall tree on right is a Lawson cypress which may or may not be within the site. Poplars in distance

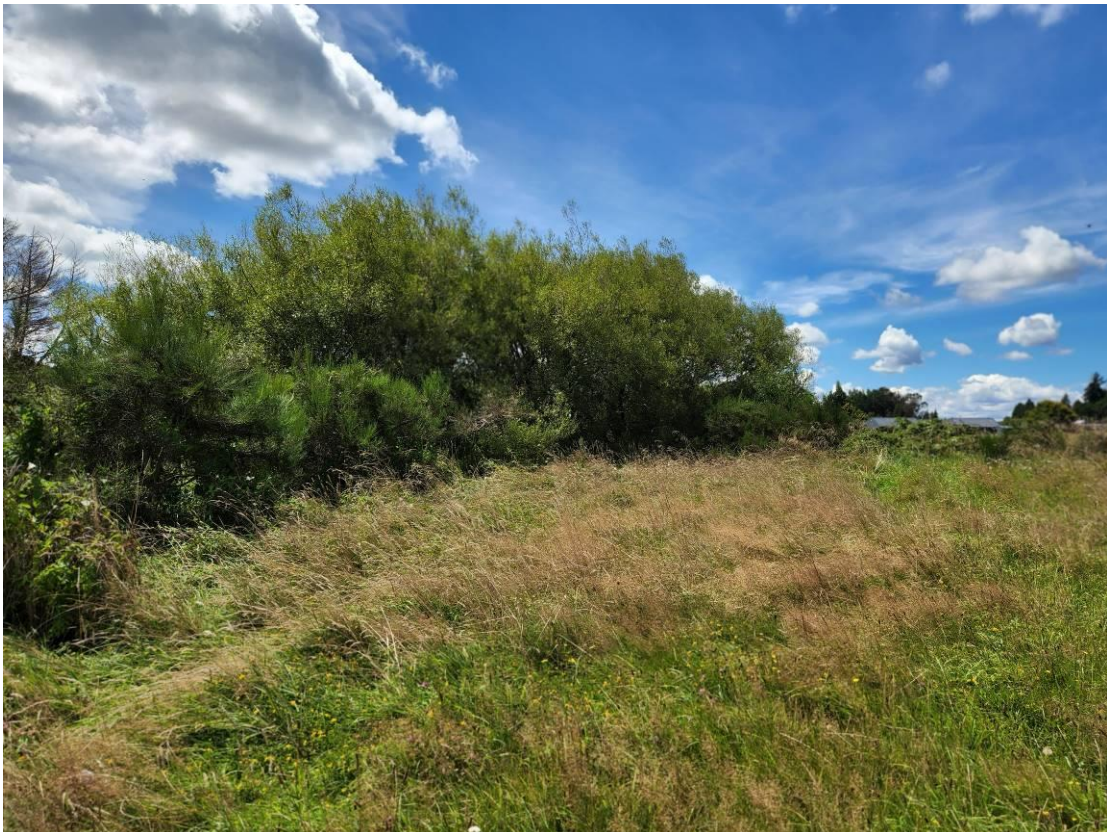
Image 29 – commencement of willow tree grove

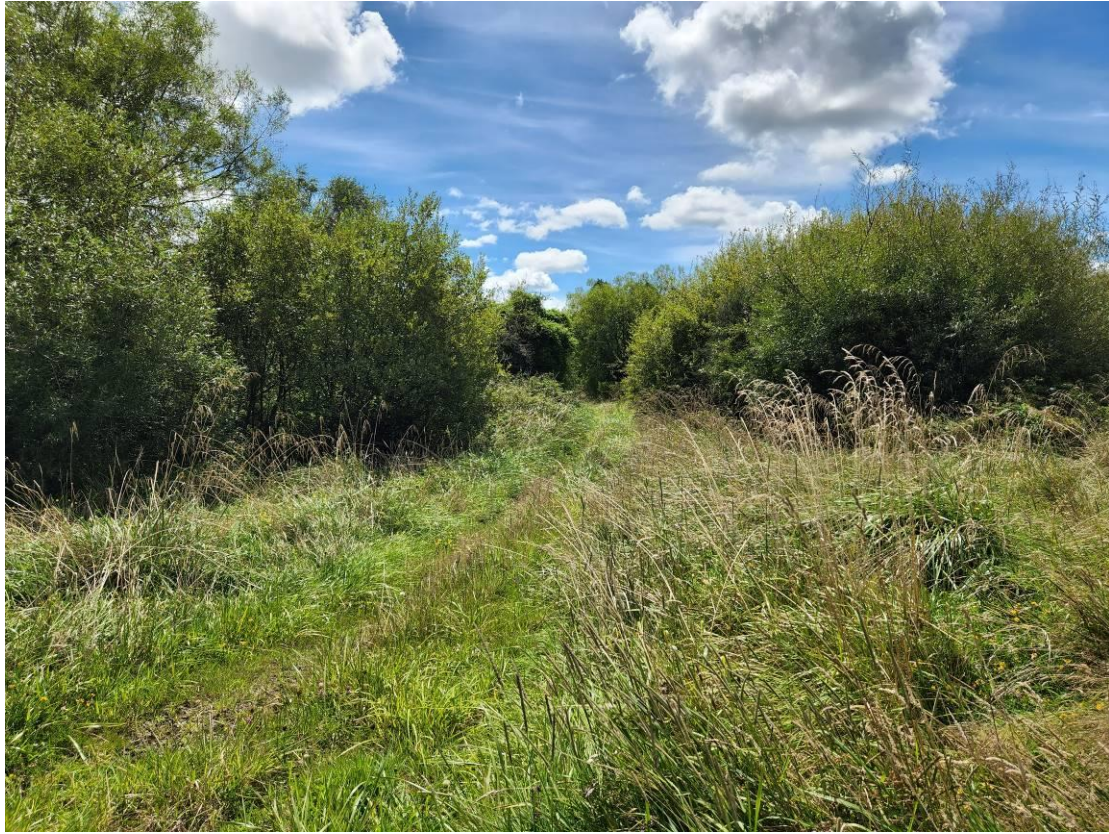
Image 30 – crossing through wetland – flanked by willow trees. Can be seen on map

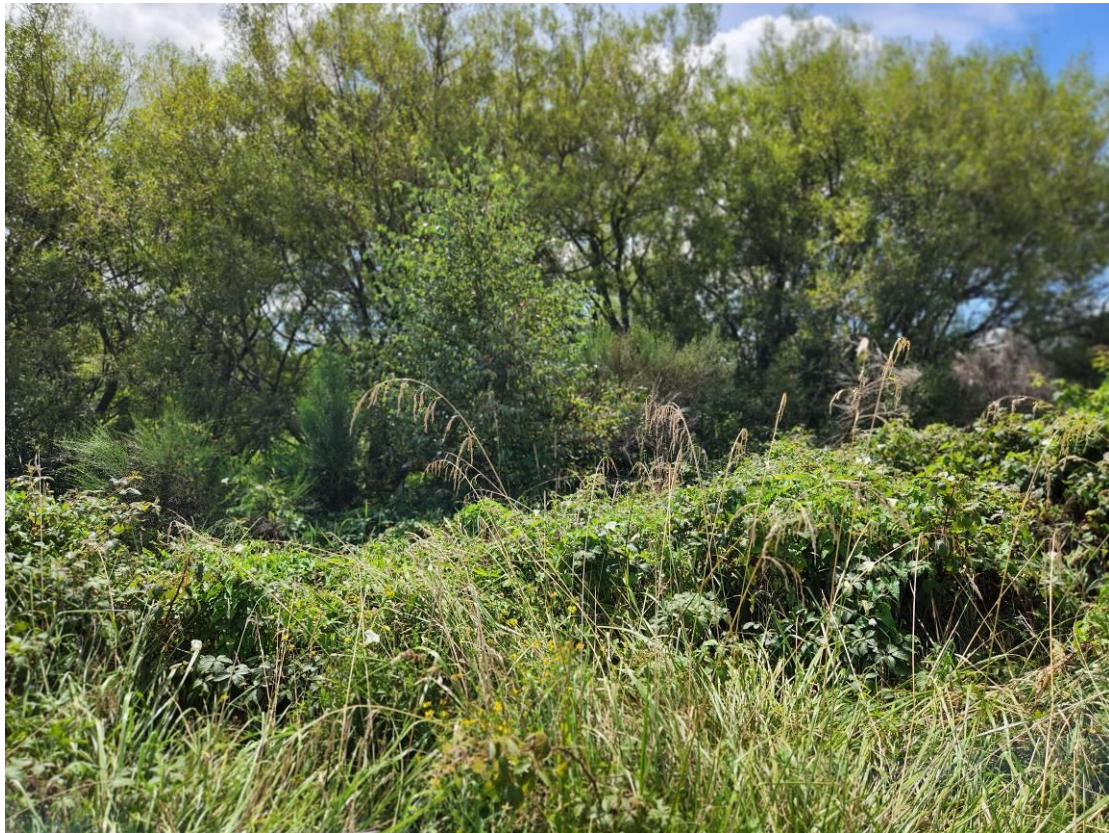
Image 31 – view of willow grove. Mass of weeds in foreground. Seedling Silver birch tree near centre of picture

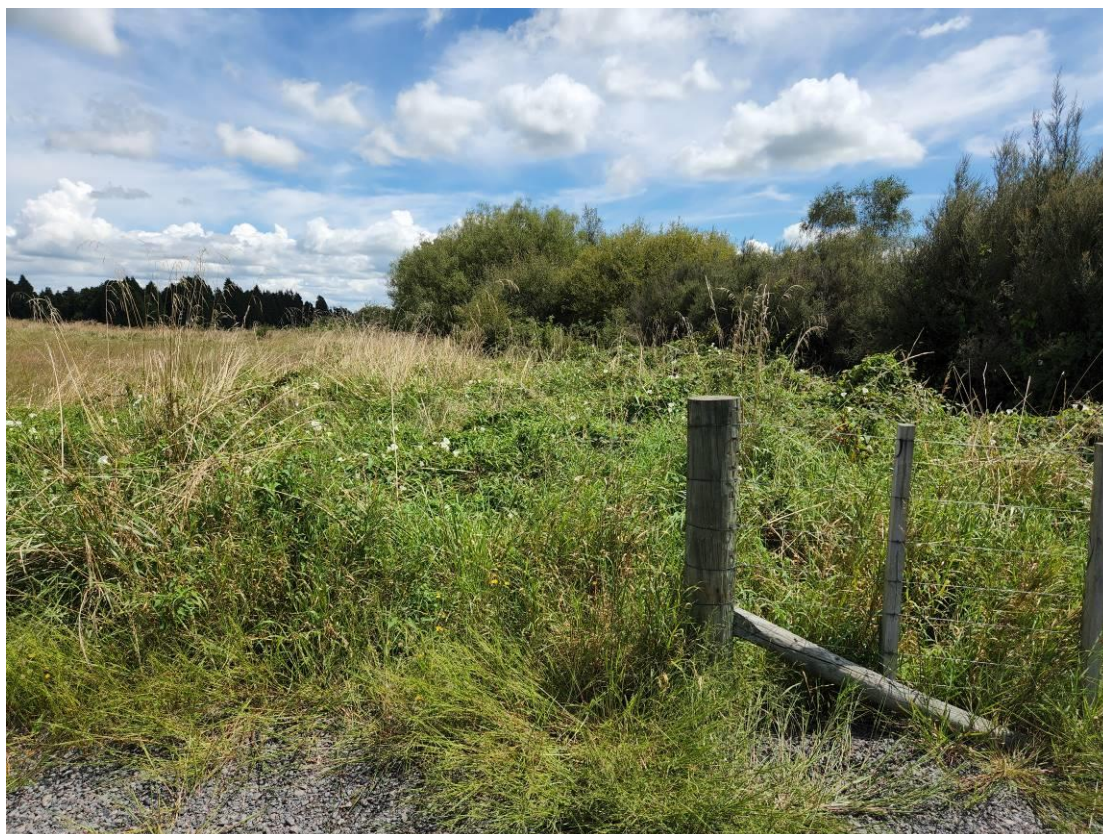
Image 32 – view to south from north corner where path from park turns to east
