Ref: Ltr-H0198f/DSI/Oct22

**RE: DETAILED SITE INVESTIGATION OF A PORTION OF 6 TEITEI DRIVE, OHAKUNE.**

**EXECUTIVE SUMMARY**

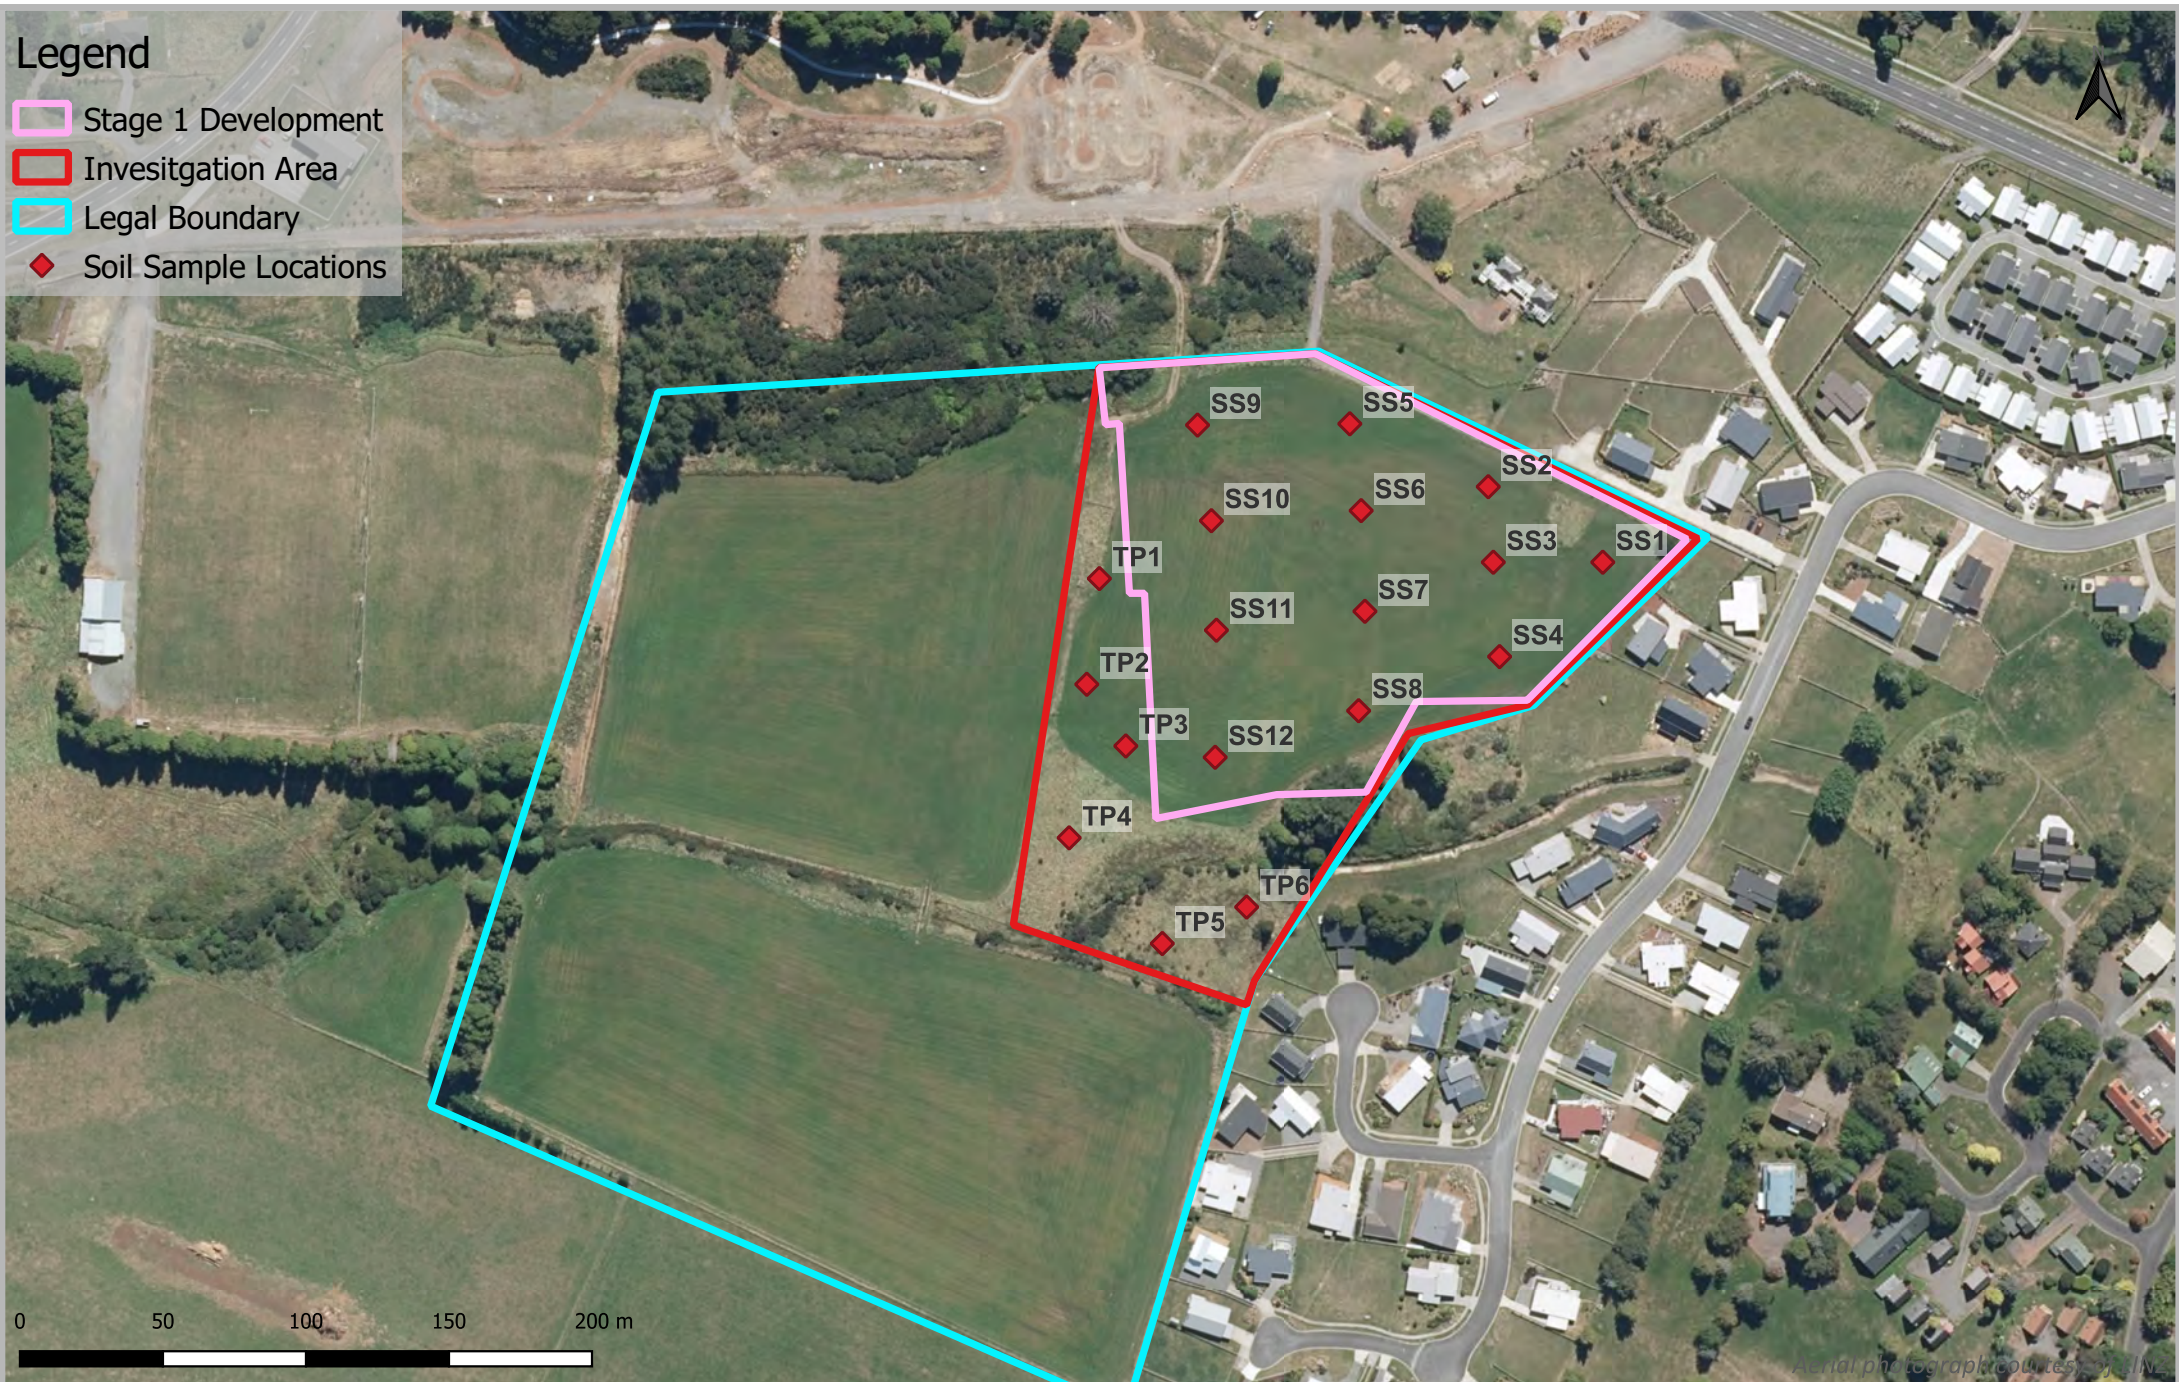
Figure 2 - Soil Sample Locations  
6 Teitei Drive, Ohakune

The first feature was a shallow stockpile of emplaced fill material encompassing approximately 200m<sup>2</sup> and some 500mm high. A hand auger borehole was advanced to 1m at the SS2 soil sample location (Figure 2) within the stockpile, which noted topsoil fill between 0-300mm, loam soil fill between 300mm - 500mm, and underlying natural sandy silt loam encountered at depths greater than 500mm. No olfactory or visual indicators of gross contamination were evident during inspection of the stockpile. As the soil is consistent with what was encountered on site and clear-cut activities have been undertaken on the walkway adjacent, it is likely the emplaced soil was excess spoil from the construction of the adjacent walkway.

GSL developed a grid-based soil sampling strategy in general accordance with the Kāinga Ora Sampling and Analysis Plan (SAP), targeting the 0-75mm soil profile, with additional soil samples collected at 300mm and 500mm depths.

Utilizing the Kāinga Ora SAP, the GSL soil sampling strategy initially comprised of eighteen discrete locations, which was reduced to seventeen due to accessibility constraints. The rate of sampling is slightly less than recommended by the Kāinga Ora SAP, however permissible due to the anticipated uniform distribution of contaminants and no indicators of potential hotspot locations (i.e. mixing sheds, buildings).

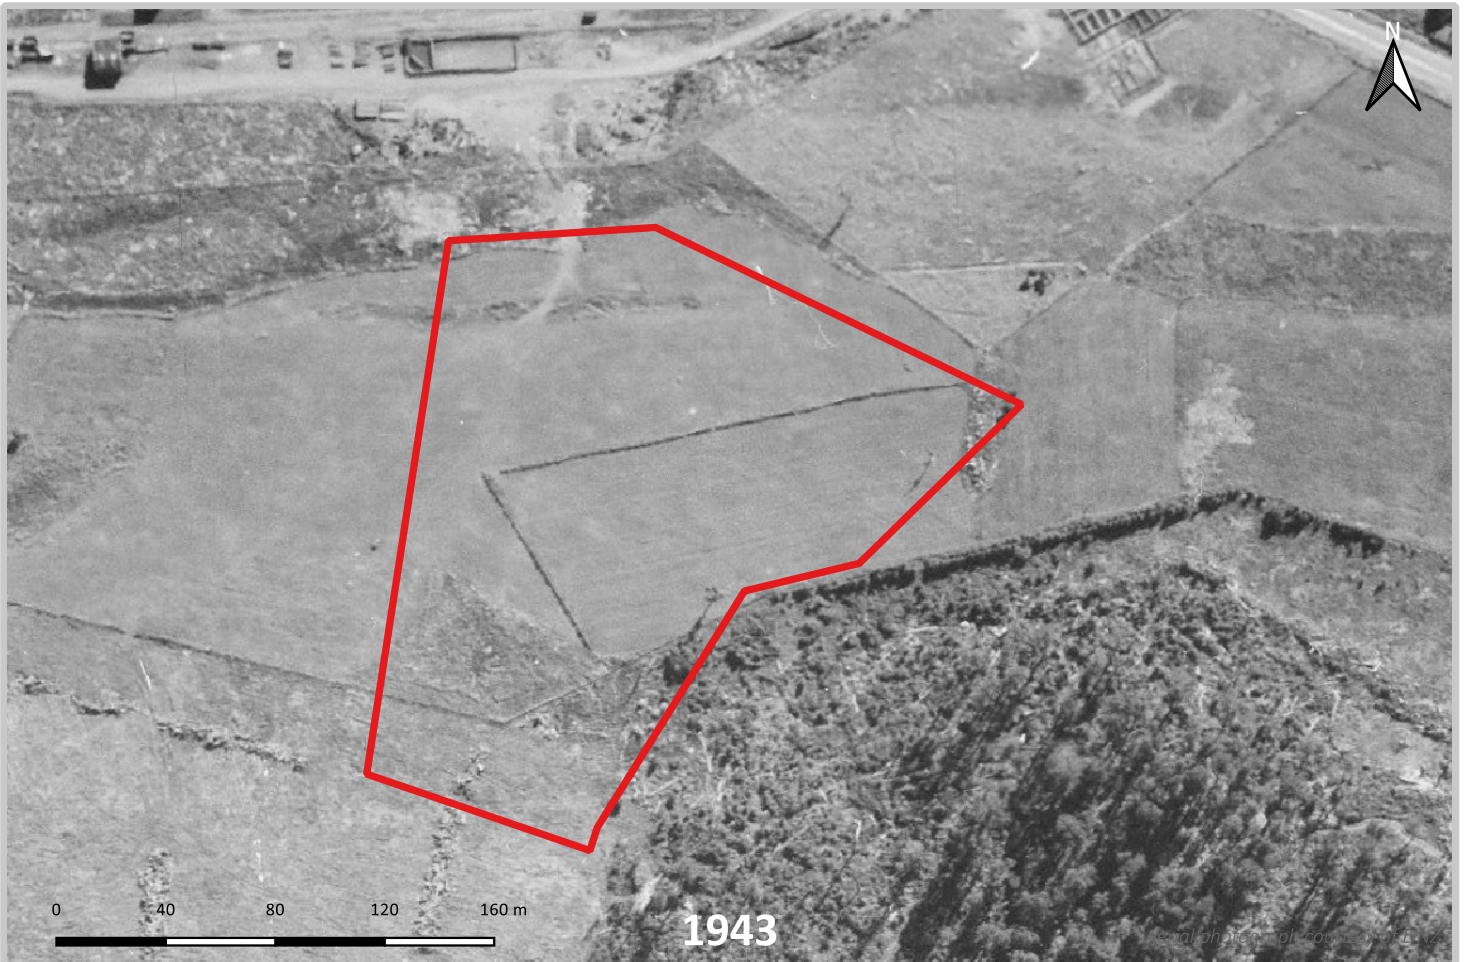
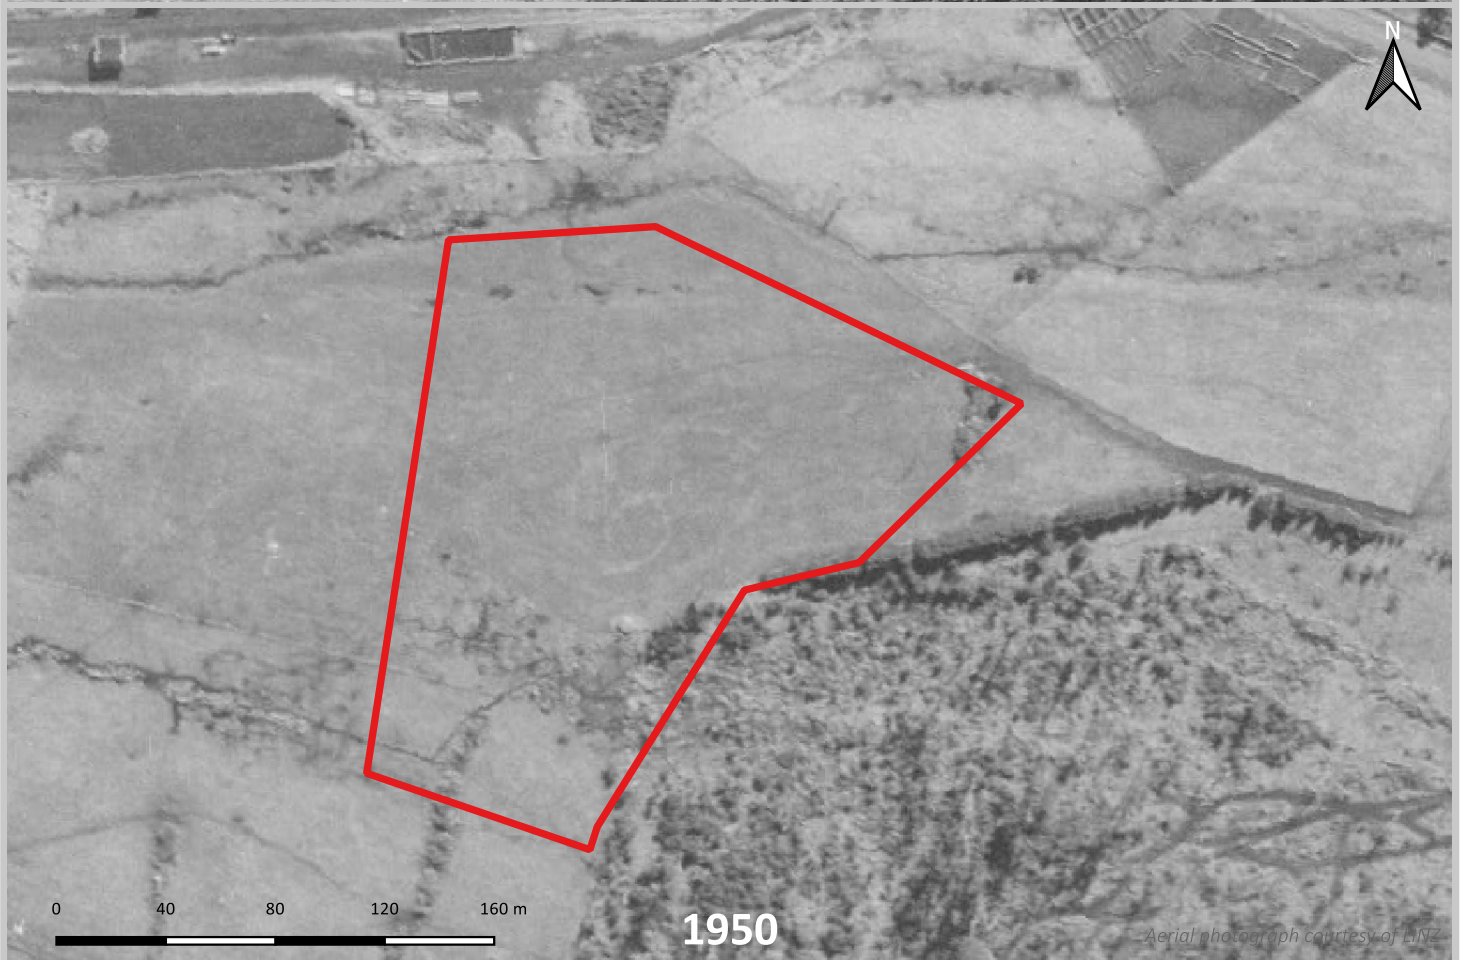
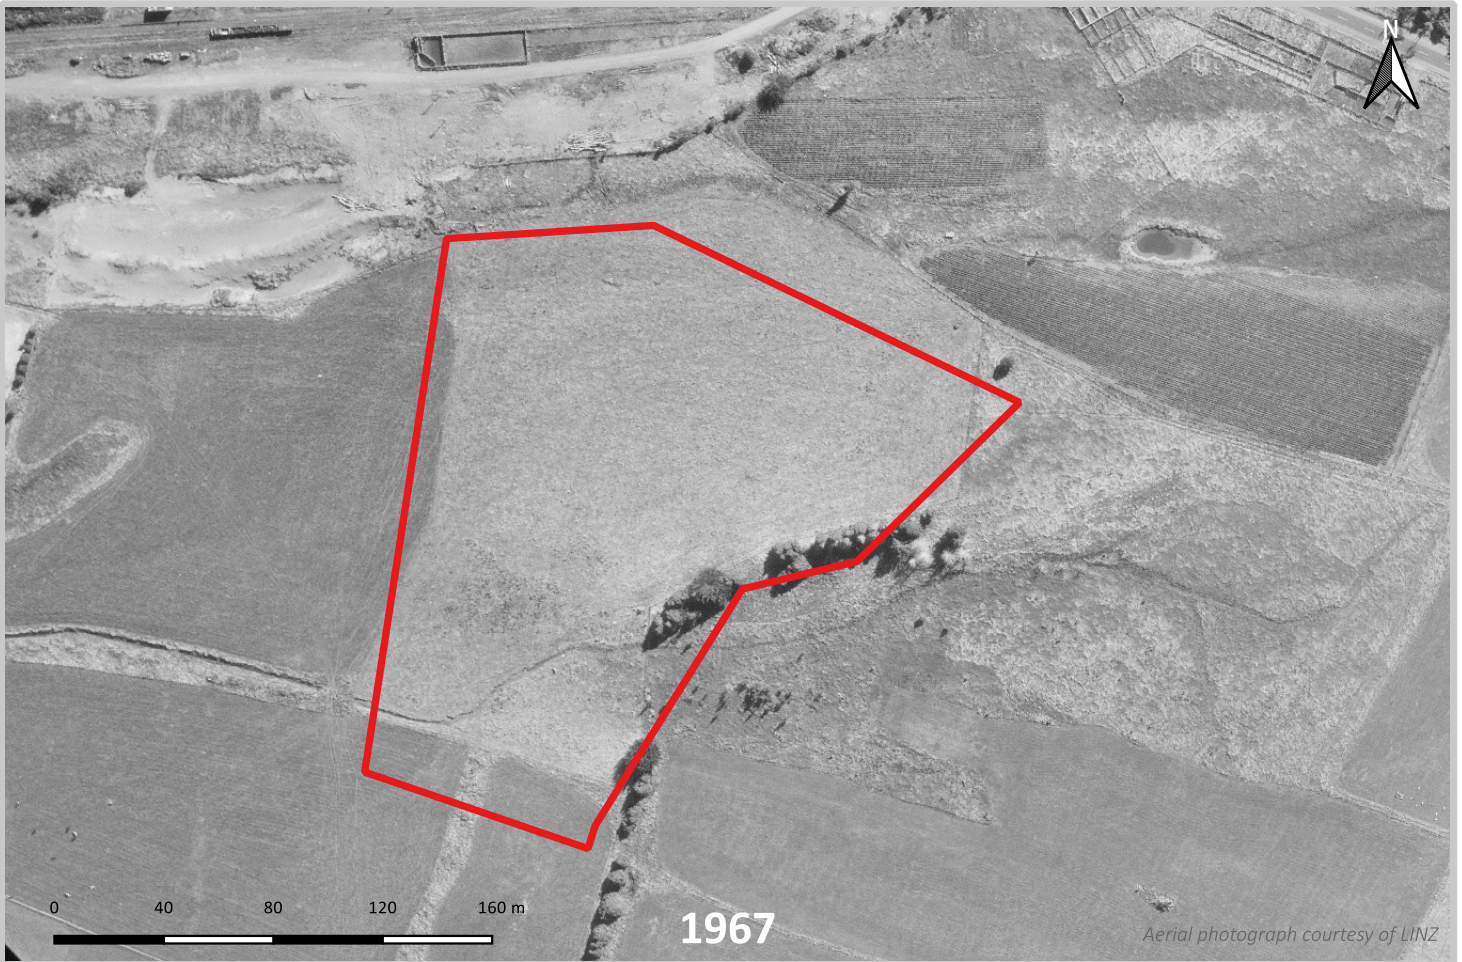
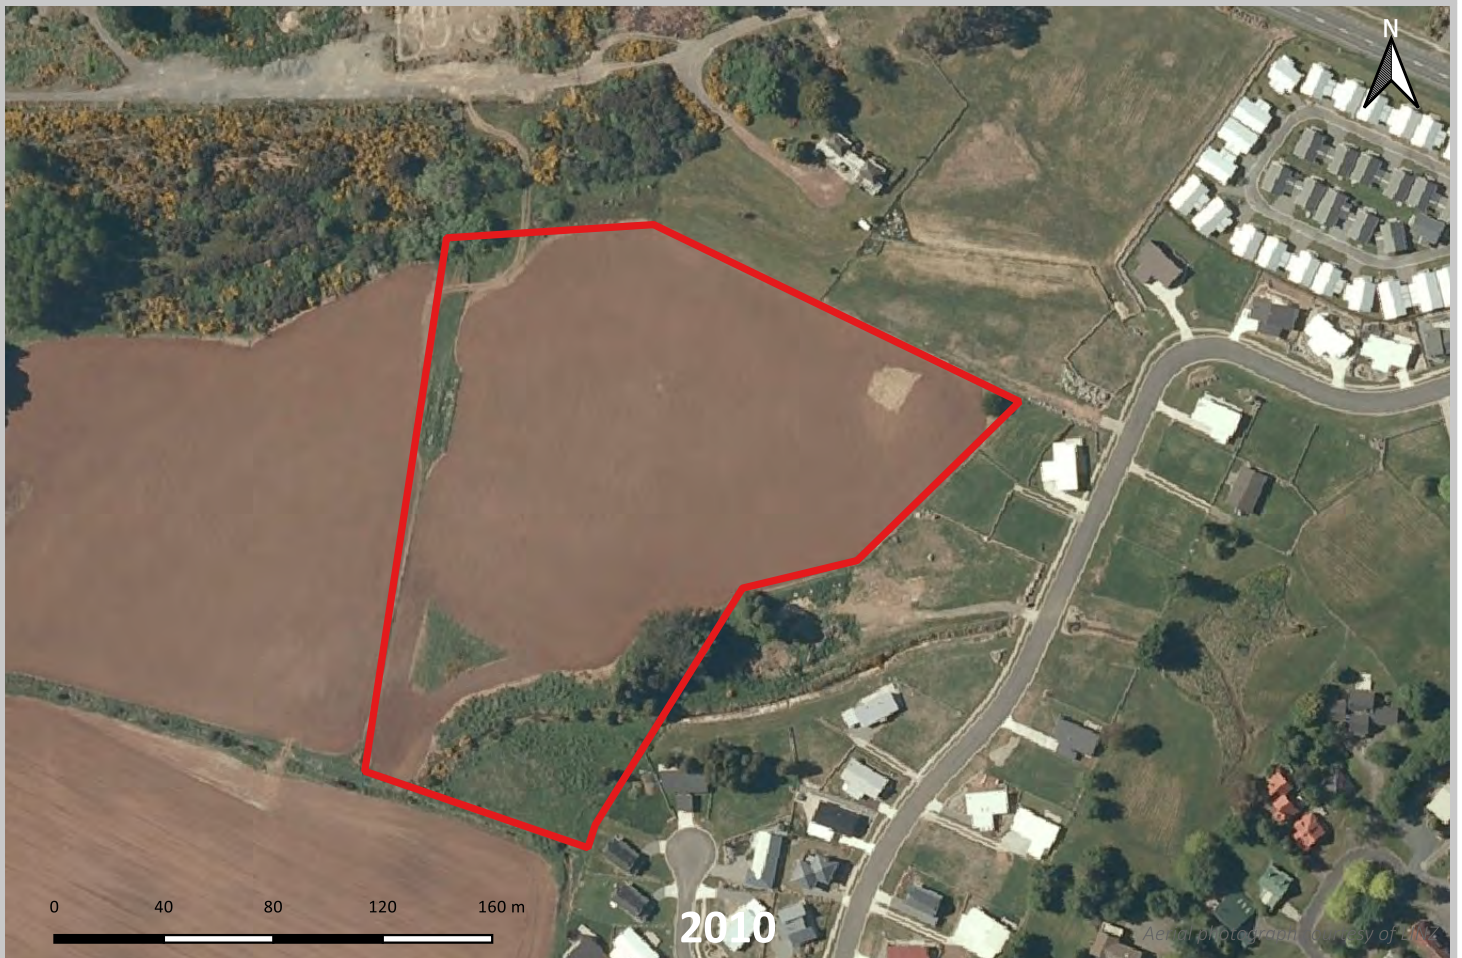
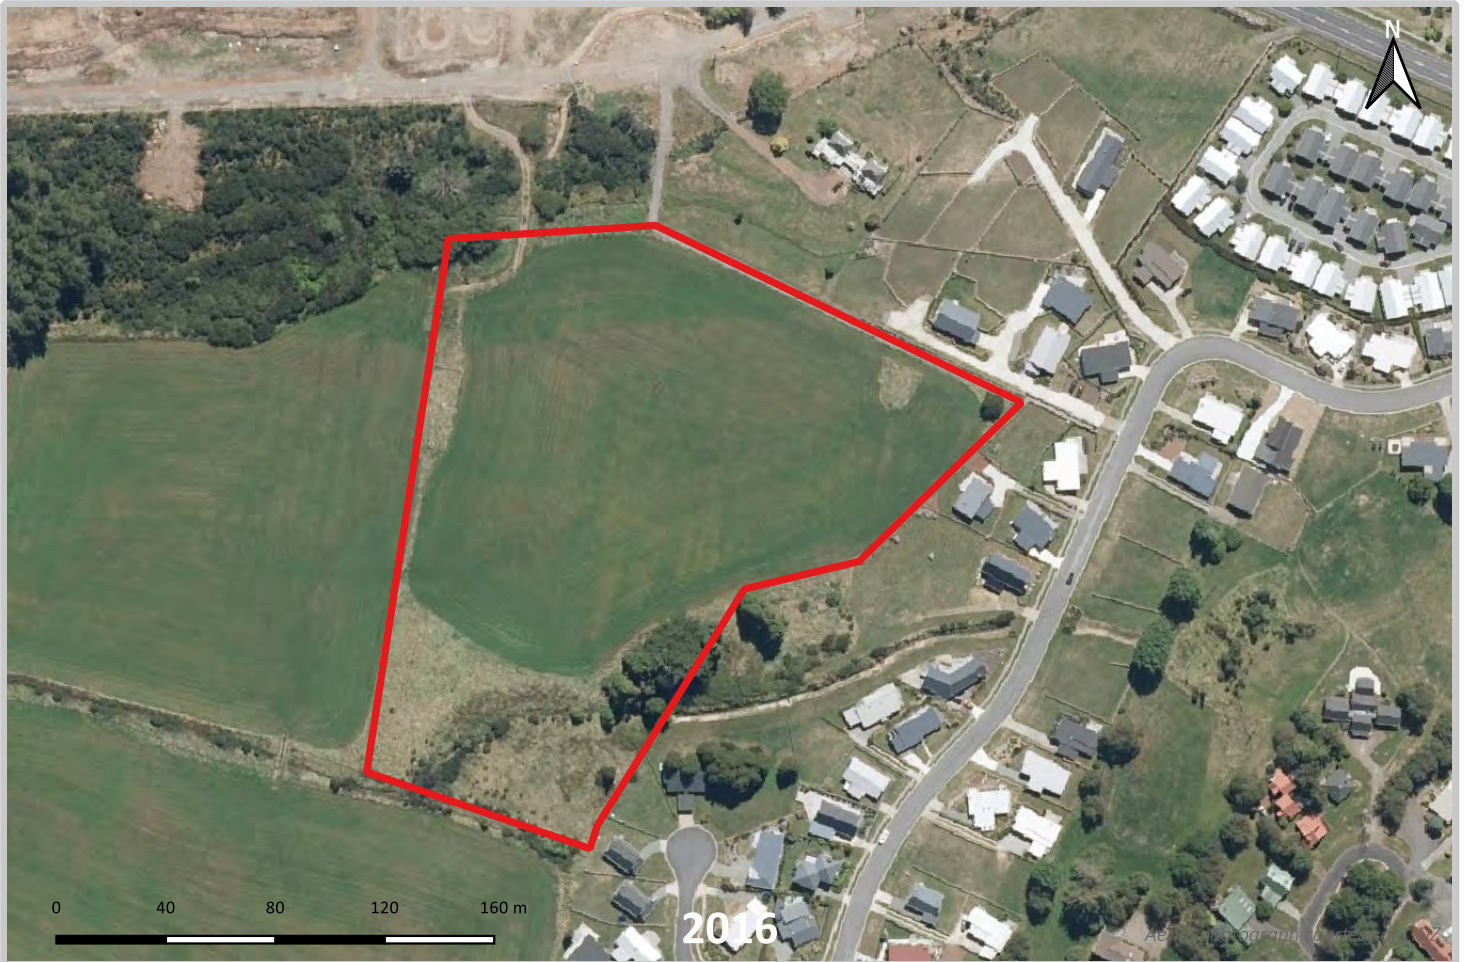
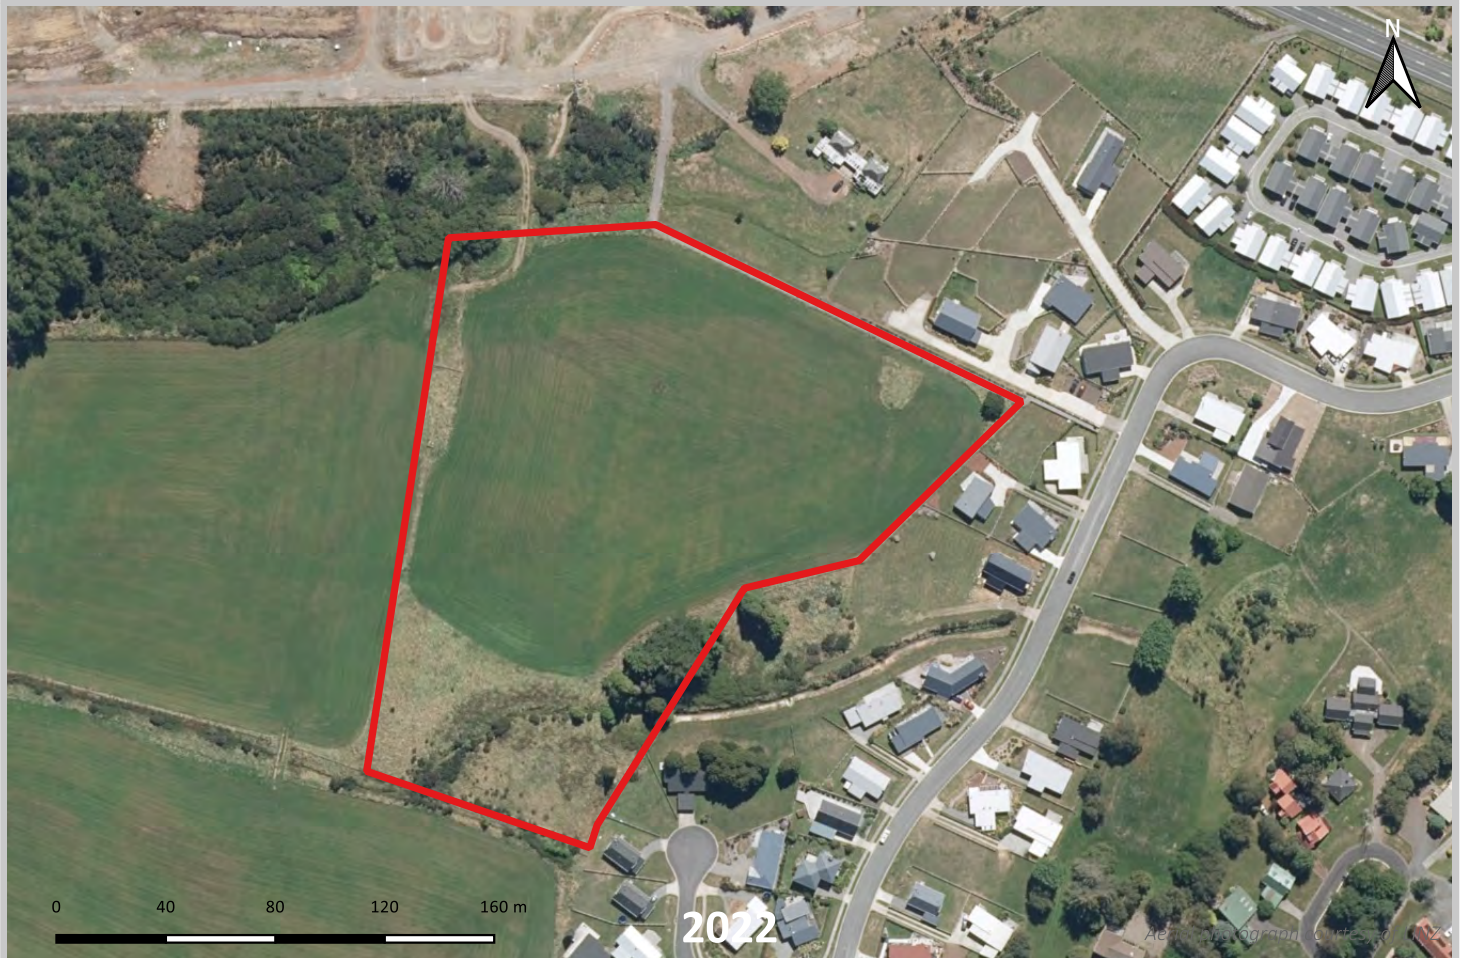
# APPENDIX A      HISTORICAL AERIAL PHOTOGRAPHS

- 1943** This is the earliest aerial image available and shows the site maintained under pasture, with several small shelter belts and piles of leftover vegetation from clearance. There are no structures or other features evident within the confines of the site boundaries. All site boundaries are bound by pasture, bush or scrub.

- 1950 – 1967** – There is little significant change to the site across these images, aside from the gradual change higher quality pasture cover. Grazing stock can be seen in the 1967 aerial image, with a stream crossing the southern extent of the site.

- 2010** Pasture cover has been removed from the majority of the site in this image, with the soil surface exposed. Furrows in the soil surface infer that the site is soon to be maintained under crop cover. The land to the east of the site has been subdivided and developed into residential housing,

- 2016 – 2022** – The site has been placed back under pasture cover in this image, with no other notable changes or development.

The site has been maintained under pasture for the majority of its discernible history, except for a short period of rotational cropping around 2010. The limited aerial image coverage for site limits distinct observations between 1967 and 2010, however it is likely the site was maintained and a pastoral and / or cropping land use during this time.

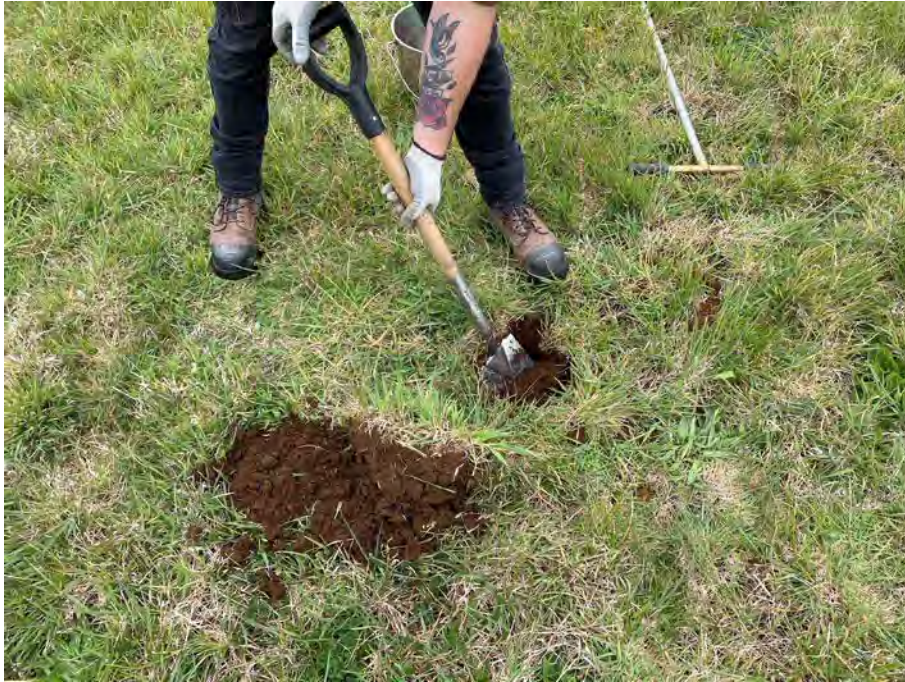
**PLATE 1: TESPIT EXCAVATION ONSITE**

Hand auger boreholes were advanced to a minimum of 500mm at each soil sample location, along with five testpits excavated to a depth of 500mm. Borehole logs from each location were typical of the natural described geology and indicate that both described geologies are present near surface onsite. The eastern two thirds of the site comprised a sandy silt volcanic loam, with a variable

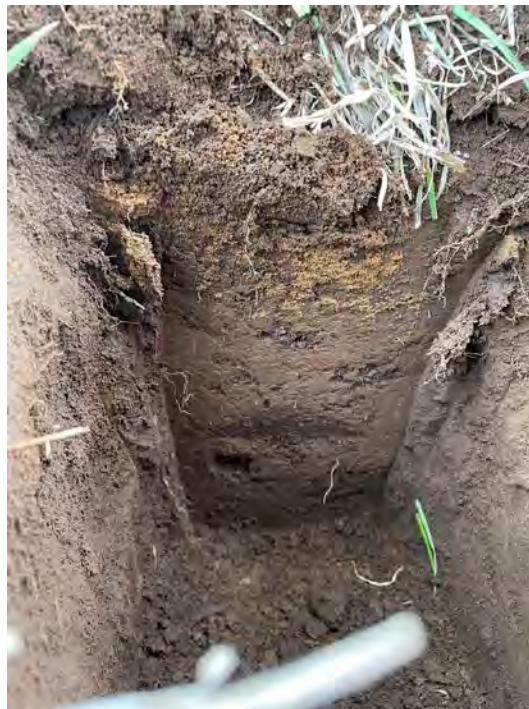
**PLATE 2: TYPICAL TOPSOIL PROFILE**

organic rich topsoil cover of 150mm – 400mm. The balance of the site comprises silt sand alluvial deposits, with some fine gravels, with 150mm – 500mm of topsoil cover.

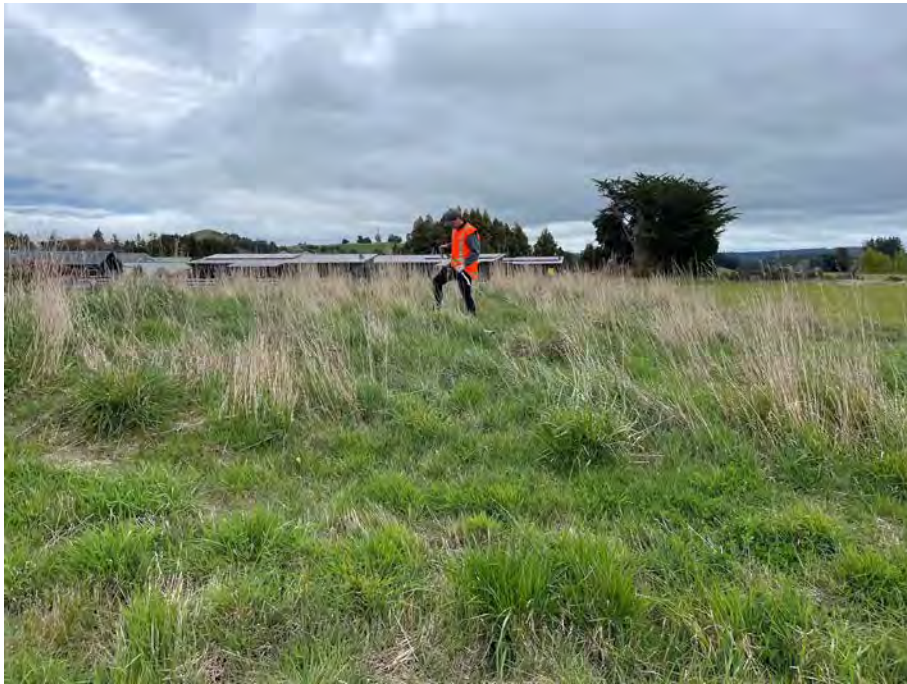
**PLATE 3: EMPLACED FILL MATERIAL**

While a stockpile of fill material was emplaced onsite, this appeared locally derived and visually absent of gross contamination indicators. Any potential contaminants within this material are likely the same as described above.

Excess spoil generated during development may be disposed of as cleanfill material.

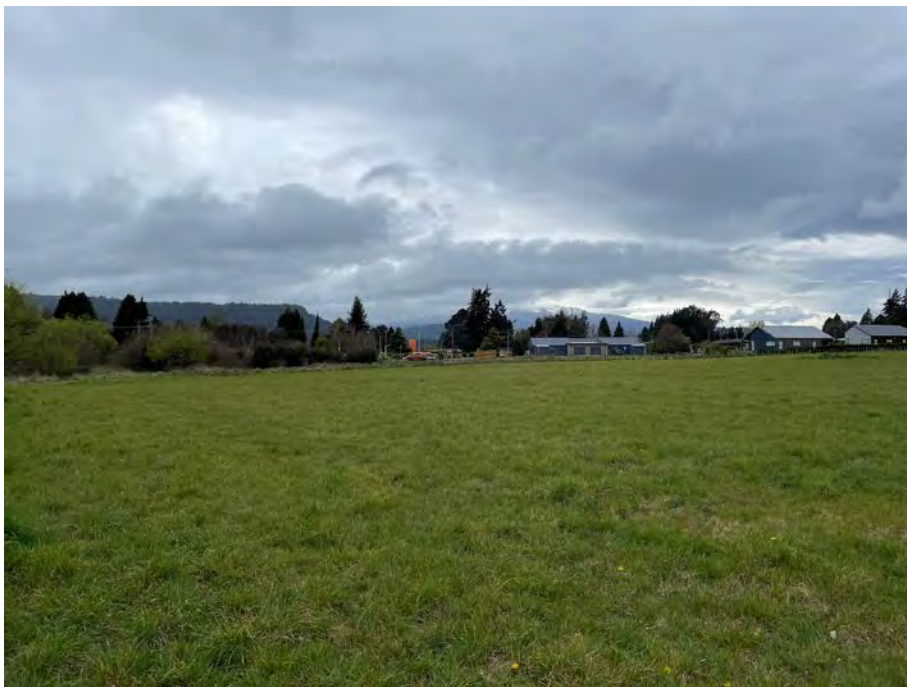
**PLATE 4: PASTURE COVER ONSITE**

GSL undertook a visual inspection of the site on 29 September 2022, during which time all external areas of the site were made available for inspection. Weather at the time of inspection was overcast with passing light showers. The majority of the site was maintained under grazing pasture, with two notable features.
