PROPOSED RESIDENTIAL SUBDIVISION

TEI TEI DRIVE, OHAKUNE

GEOTECHNICAL INTERPRETATIVE REPORT

TGA2022-0238AC Rev 0

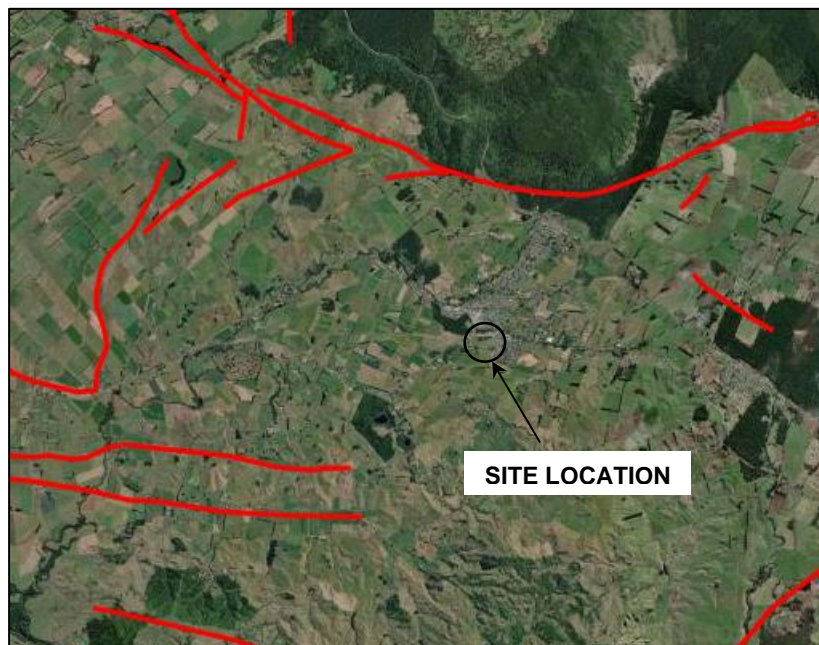
Figure 3: Active Faults (3a - GNS Active Fault Database, 3b – Horizons Regional Council Natural Hazard Viewer)

The Institute of Geological and Nuclear Science (GNS)¹² and Horizons Regional Council Natural Hazard Viewer¹³ show several active faults to the north, south, east, and west, as shown on Figure 3 below. These are approximately 1km to 5km away from site. The closest known active fault to the site is an unnamed fault 1.1km to the north.

The distance to the nearest fault suggests a low risk of fault rupture affecting the subject site.

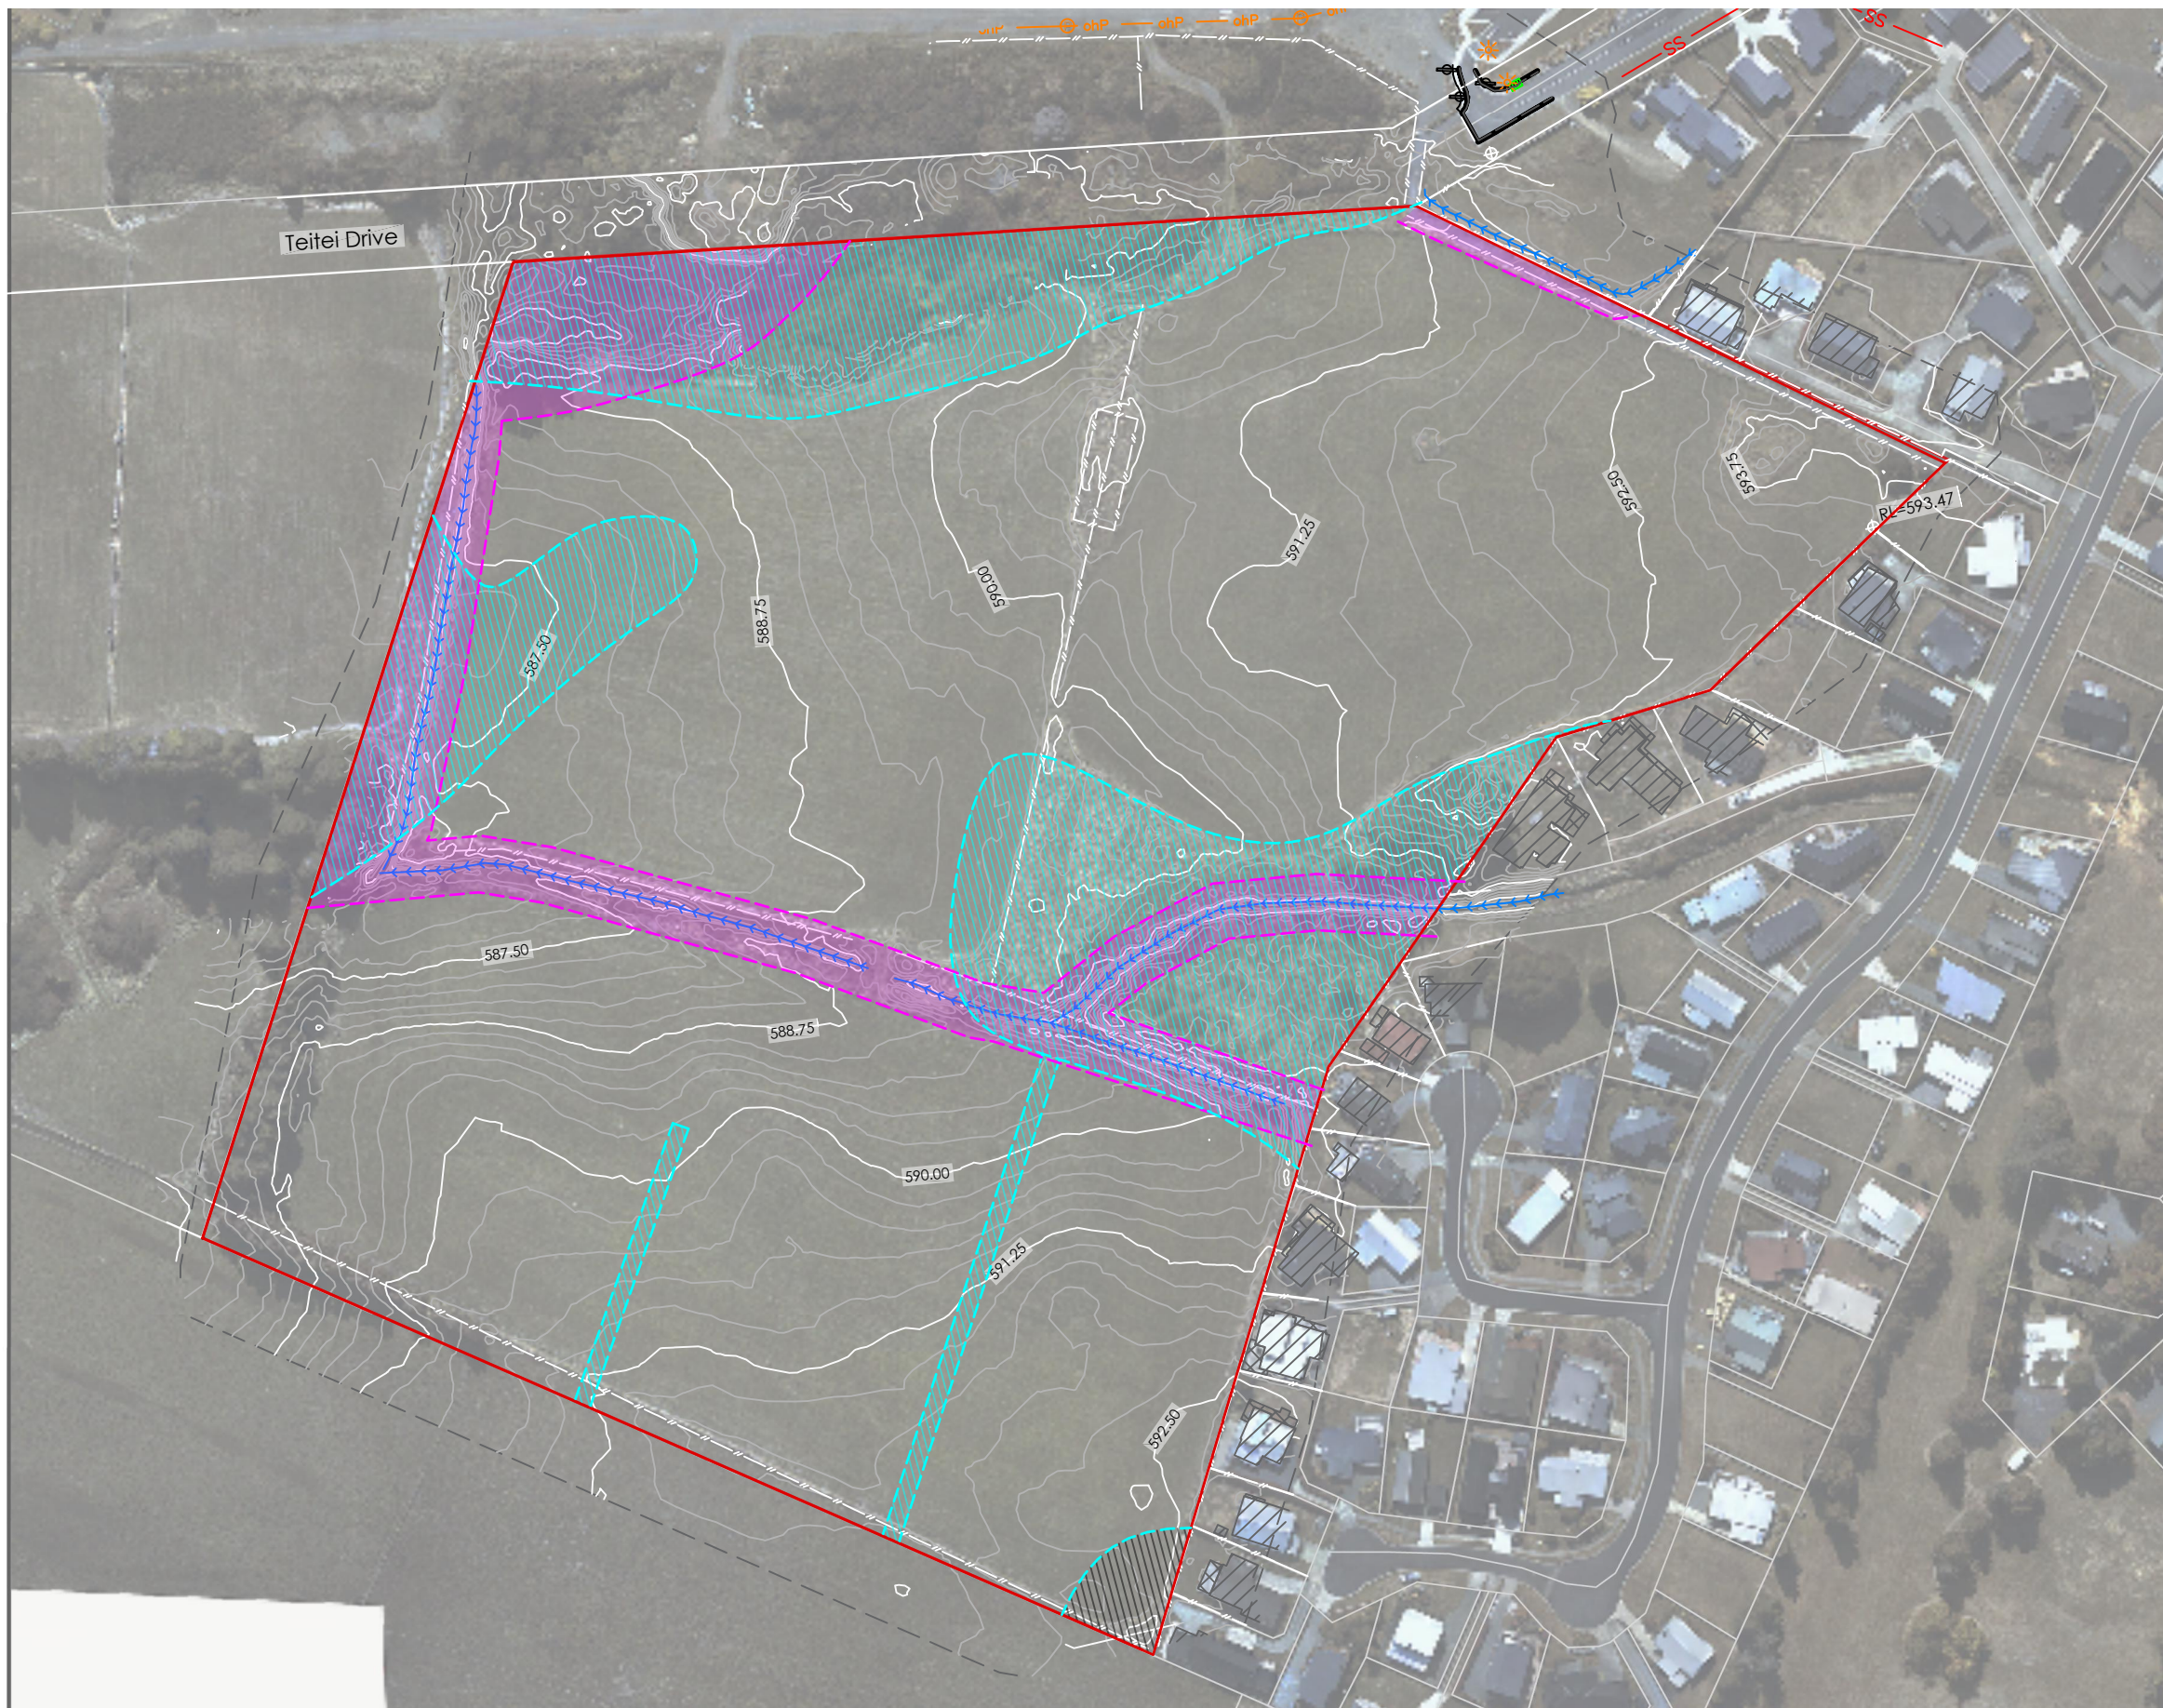
CLIENT:	CHEAL CONSULTANTS LTD	DRAWN:	HR	PROJECT:	TGA2022-0238
PROJECT:	TEITEI DRIVE, OHAKUNE	CHECKED:	EE	DRAWING:	02
TITLE:	GEOTECHNICAL HAZARD PLAN	REVISION:	0	SCALE:	1:1500
		DATE:	16/02/2023	SHEET:	A3 L

The uncontrolled fill encountered within the former gullies / channels, as shown on **Drawing 02**, is variable in strength and organic content, and future loads may induce settlements that are likely to be greater than the recommended tolerances provided in the NZ Building Code. Mitigation options are discussed in Section 8.3.3.

Based on the current landform, a building restriction line (BRL) set back at least 5 metres from the crest of the open drains, has been nominated for the site. The Slope Instability Hazard Zone, as shown on **Drawing 02**, is defined by this BRL. All structures requiring building consent must be located outside the Slope Instability Hazard Zone unless supported by further geotechnical investigation and/or assessment by a Chartered Professional Geotechnical Engineer;

The uncontrolled fill encountered within the former gullies / channels, as shown on **Drawing 02**, is variable in strength and organic content. As such these areas of the site will need to be over-excavated and replaced with engineered fill. The subgrade should be observed by the project geotechnical engineer prior to fill placement.

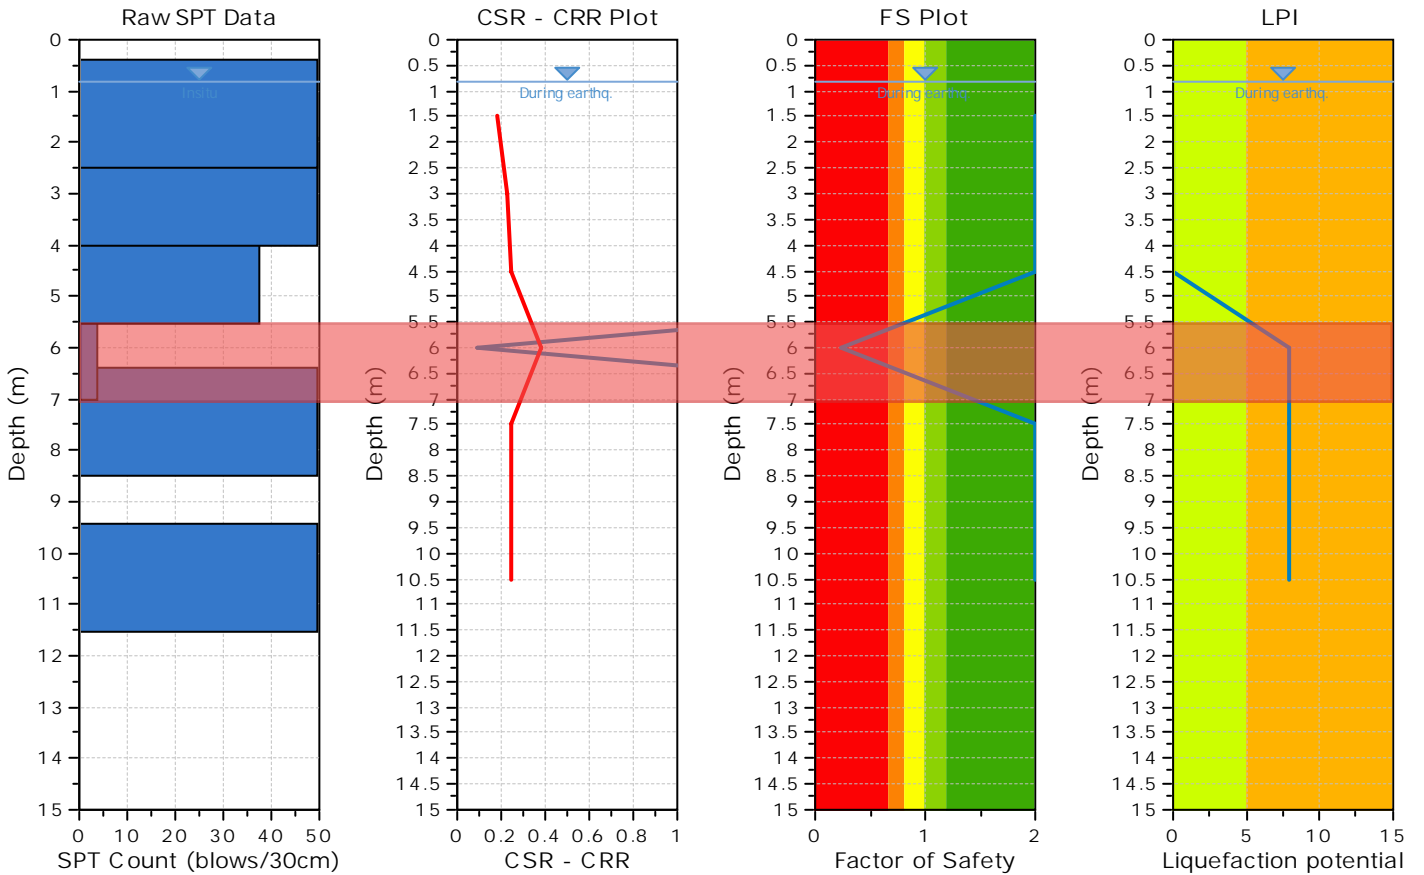
SPT BASED LIQUEFACTION ANALYSIS REPORT

Quantitative liquefaction susceptibility analyses was carried out using the computer software package LiqSVs 2.0, based SPT N-values obtained from the machine boreholes and in accordance with Boulanger & Idriss (2014) method. Results demonstrate that liquefaction triggering occurs where SPT N-values are less than approximately 12 to 15, which as described above are generally limited to isolated layers within the soil profile with significantly higher N values above and below.

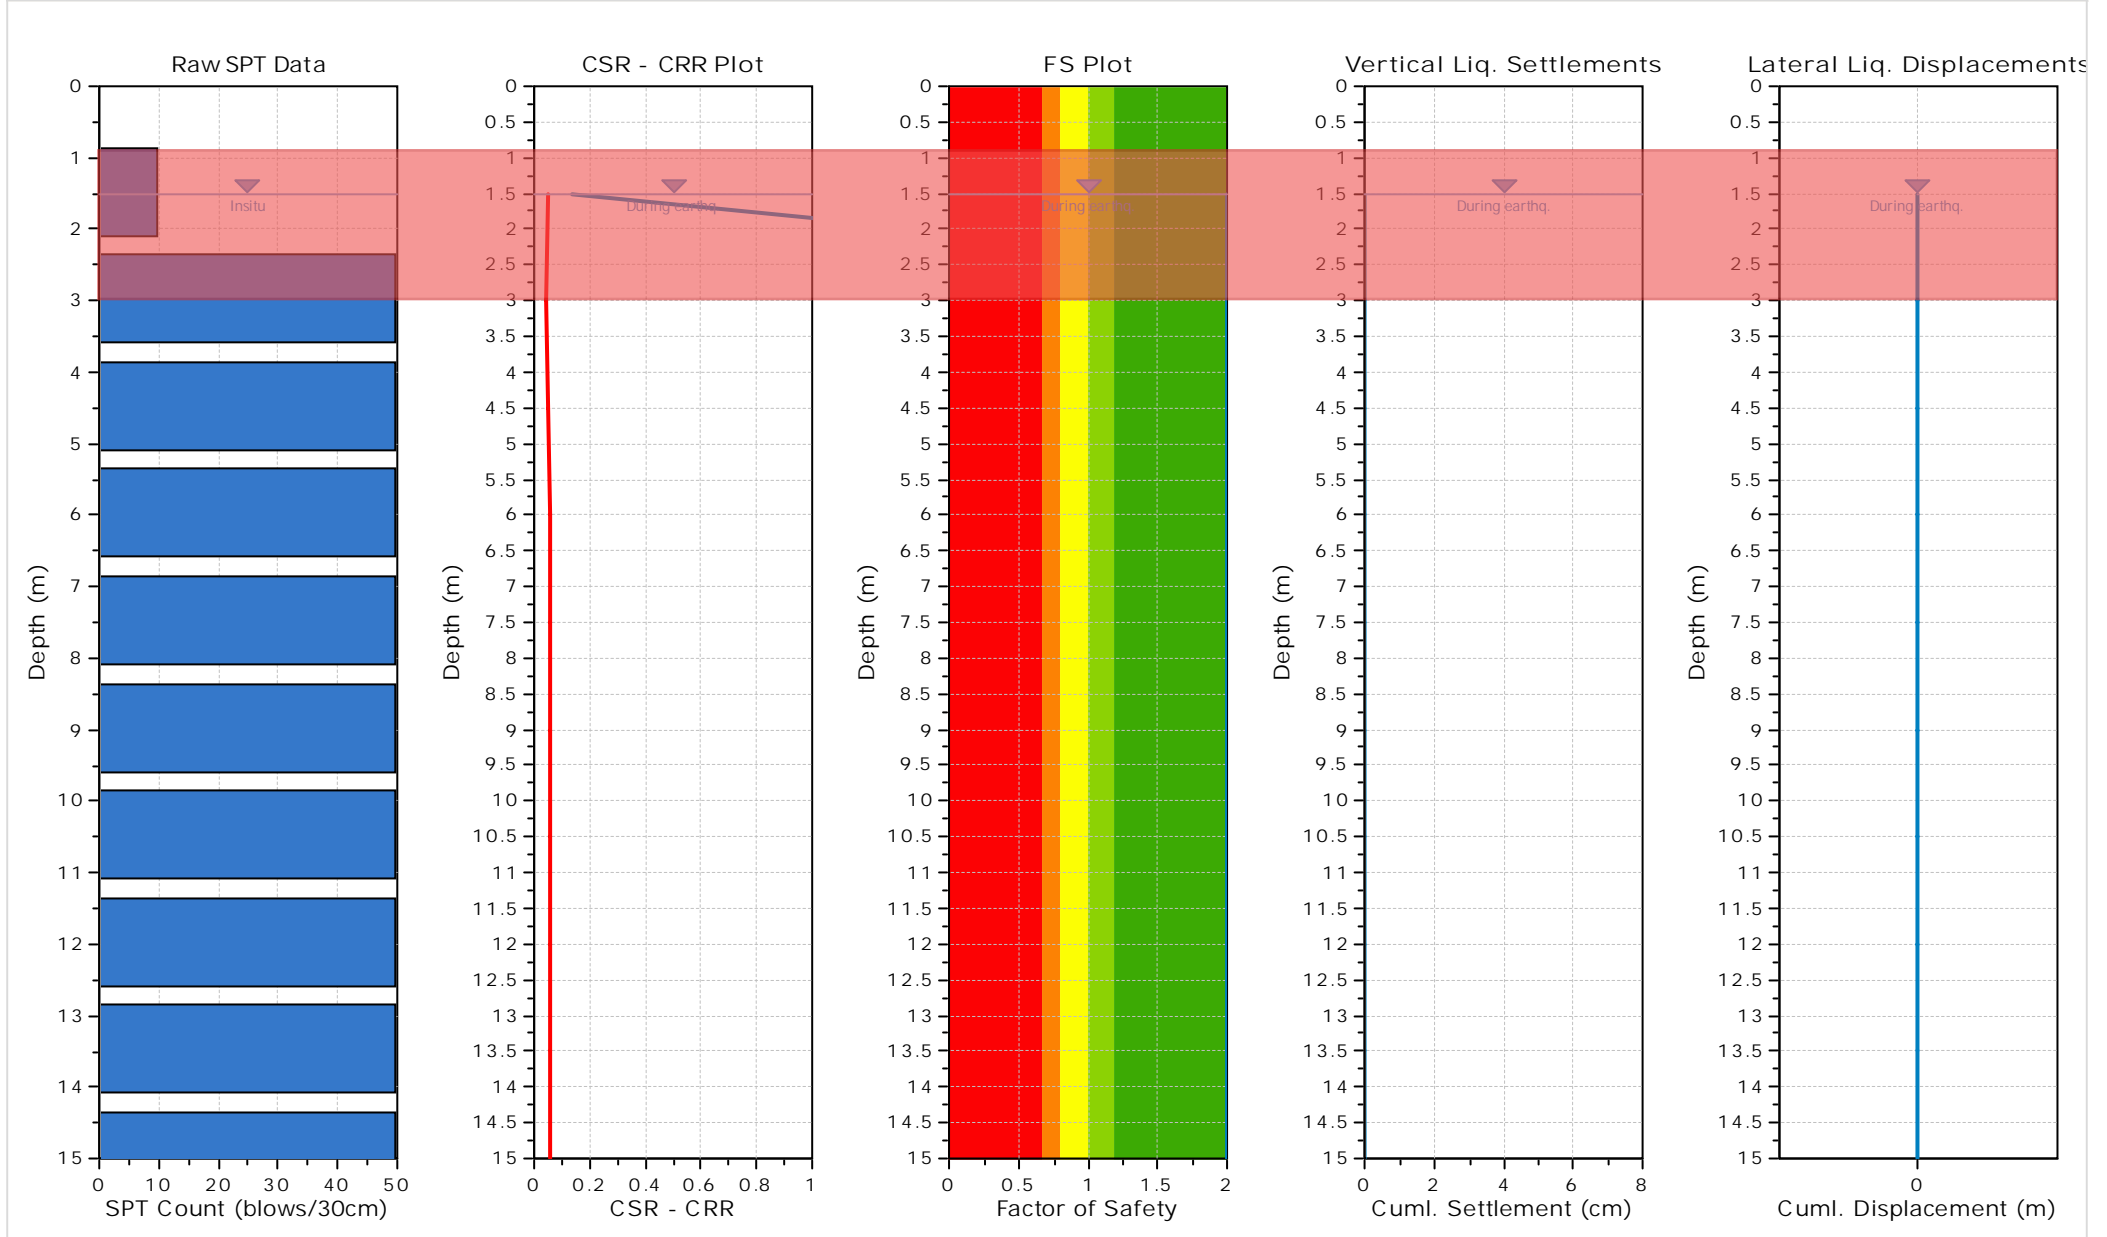
:: Overall Liquefaction Assessment Analysis Plots ::

- F.S. color scheme
- Almost certain it will liquefy
 - Very likely to liquefy
 - Liquefaction and no liq. are equally likely
 - Unlike to liquefy
 - Almost certain it will not liquefy
- LPI color scheme
- Very high risk
 - High risk
 - Low risk

Conventionally CPT traces are used to carry out liquefaction analyses, however given that all the CPTs terminated at shallow depths (typically at depths less than 2.0mbgl), SPT N-values were used to undertake specific liquefaction analyses for the site. Based on experience on other sites within the region with similar ground conditions, liquefaction is unlikely to be triggered for the design PGA in soils with SPT N-values greater than 30.
