## Memorandum

<b>Date:</b>	17/05/2023
<b>To:</b>	Katherine Hu, Sunil Prasad, Rachel Griffiths, James Pattullo
<b>From:</b>	Andrew Rossaak
<b>CC:</b>	Fletcher Wilson
<b>Project Number:</b>	P04109
<b>Reviewed and released by:</b>	Stu Farrant

### Subject: Teitei Drive wetlands and stormwater

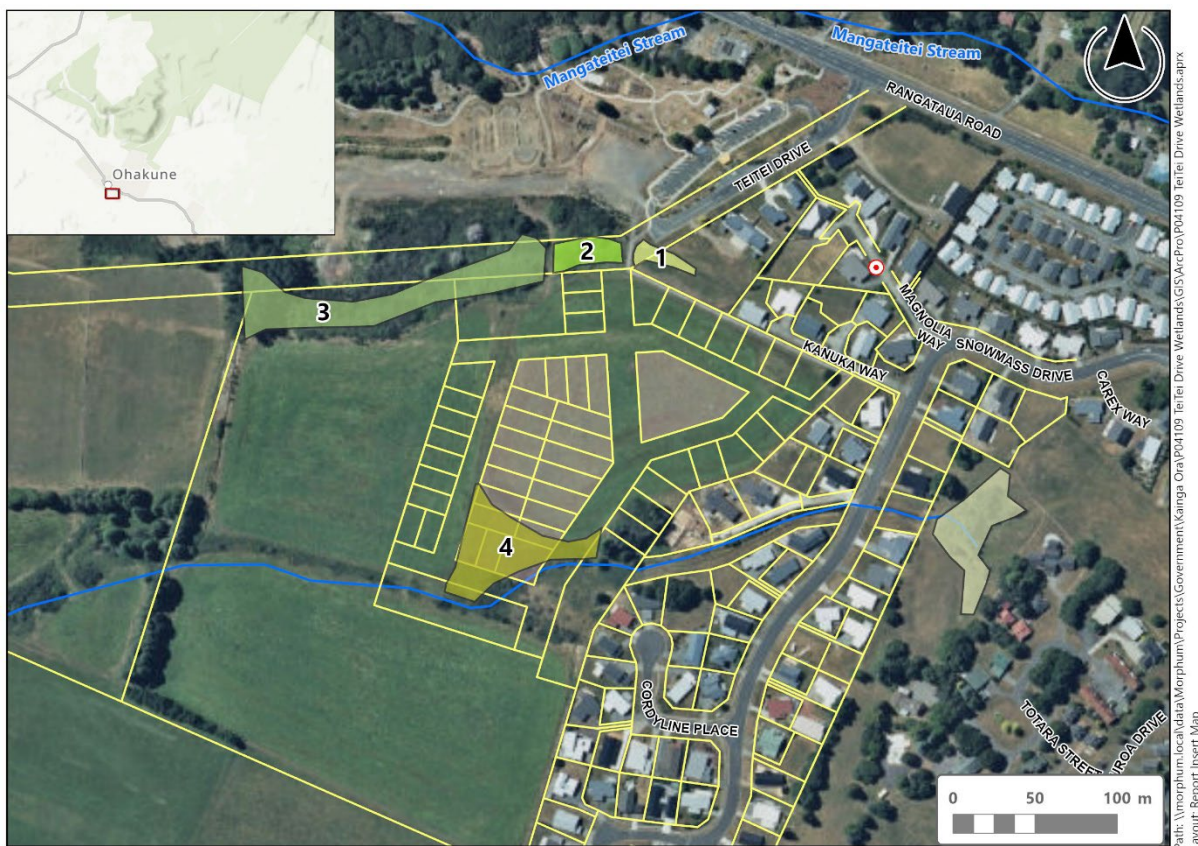
Preliminary ecological assessments had identified 4 potential wetland areas on or close to the site<sup>1</sup>. Three of these are along a watercourse/gulley system forming the northern boundary of the site and the fourth is in the south of the site (Figure 1). All potential wetlands were assessed using the NES:F wetland delineation protocols<sup>2</sup>.

The potential wetland in the south of the site (labelled wetland 4 in Figure 1) is a roughly triangular shape and is bordered on the southeast and southern extent by a modified stream. The western extent follows a fence-line, and the northern extent follows a farm track. The vegetation comprised of rank

pasture grass (tall fescue) with patches of *Ranunculus acris*, an exotic species that is easily spread by stock and machinery and is commonly known as meadow buttercup or giant buttercup. This species often grows in moist areas, but is not a determination of wetland, being noted as a facultative species on the wetland plant indicator status rating 2021<sup>3</sup>. It is also considered to be poisonous to livestock and avoided by dairy cattle<sup>4</sup>, which could explain why this area is not included in the hay/silage harvesting conducted on the site. With the *Ranunculus* species being facultative (tall fescue is not on the list), vegetation is inconclusive in determining a wetland at this location and as such further assessment of the vegetation would not add to the wetland determination. The site was assessed using the hydrology and hydric soil tools. The site was slightly downslope, and a stream bordered one side, however there were no indicators of inundation. Soil augers were undertaken in three locations well into the area labelled 4 (Figure 1). The soils were damp near the surface, but dry and friable at a depths of 150 to 300 mm with a colour indicating there was no glaying (Munsel 10YR 5/4) (Figure 2). No matrix or mottles were present. This indicates that this is not a wetland as it lacks wetland hydrology and hydric soils. It is likely that this area is vegetatively different from the rest of the paddock as it has not been mown and allowed to grow rank with resulting increased moisture in the vegetated matter.

**Figure 1: Potential wetlands identified by ecology assessment.**

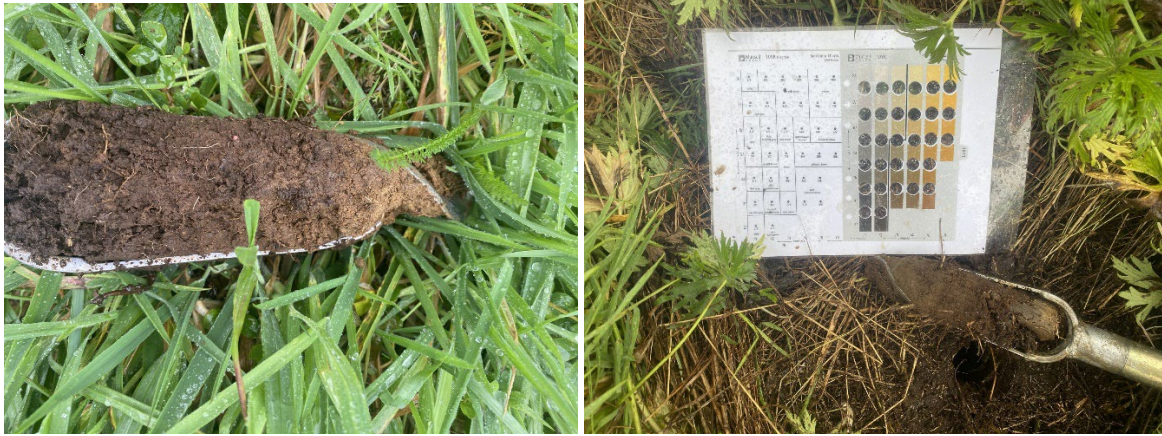
**Figure 2: Soils in potential wetland area 4 illustrating dry lower horizon and red colours.**

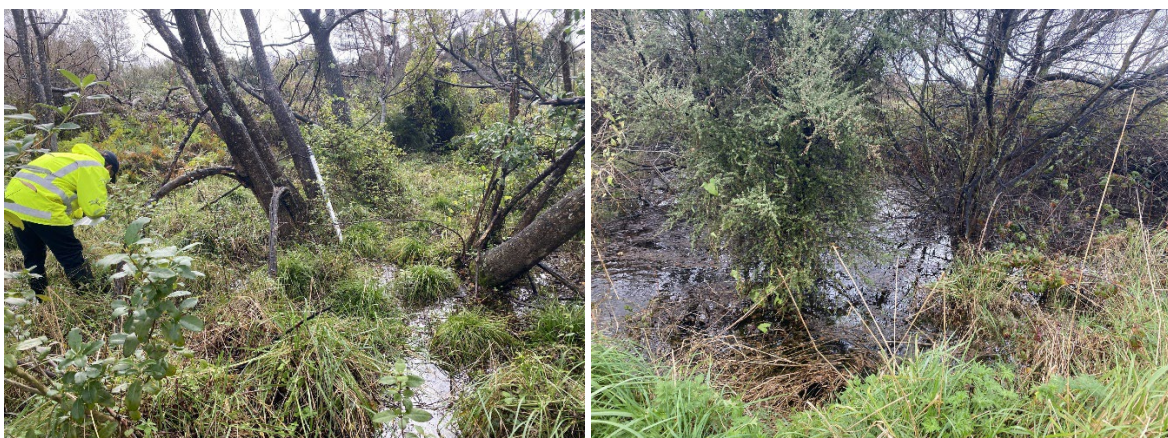
Potential wetland 3 is immediately downstream of wetland 2. It was also flooded into the pasture grass edge at the time of the site visit (Figure 3). Vegetation is similar to wetland 2 and based on the evidence of regular flooding and very wet soils, this too is considered a natural wetland under the NES:F.

**Figure 3: Potential wetland area 3.**

Wetland 3 was followed downstream where the surface water disappeared. Following the watercourse is limited by the dense vegetation and as such there is uncertainty as to the fate of this water flow. Further assessment may be required. It was noted that there were dry soils in the gully at the western extent of potential wetland 3. The surface was irregular and it is suggested that this area may be an old waste fill area. Historical imagery from Retrolens shows a railway line existed near this location and that there is likely to have been earthworks at this location.

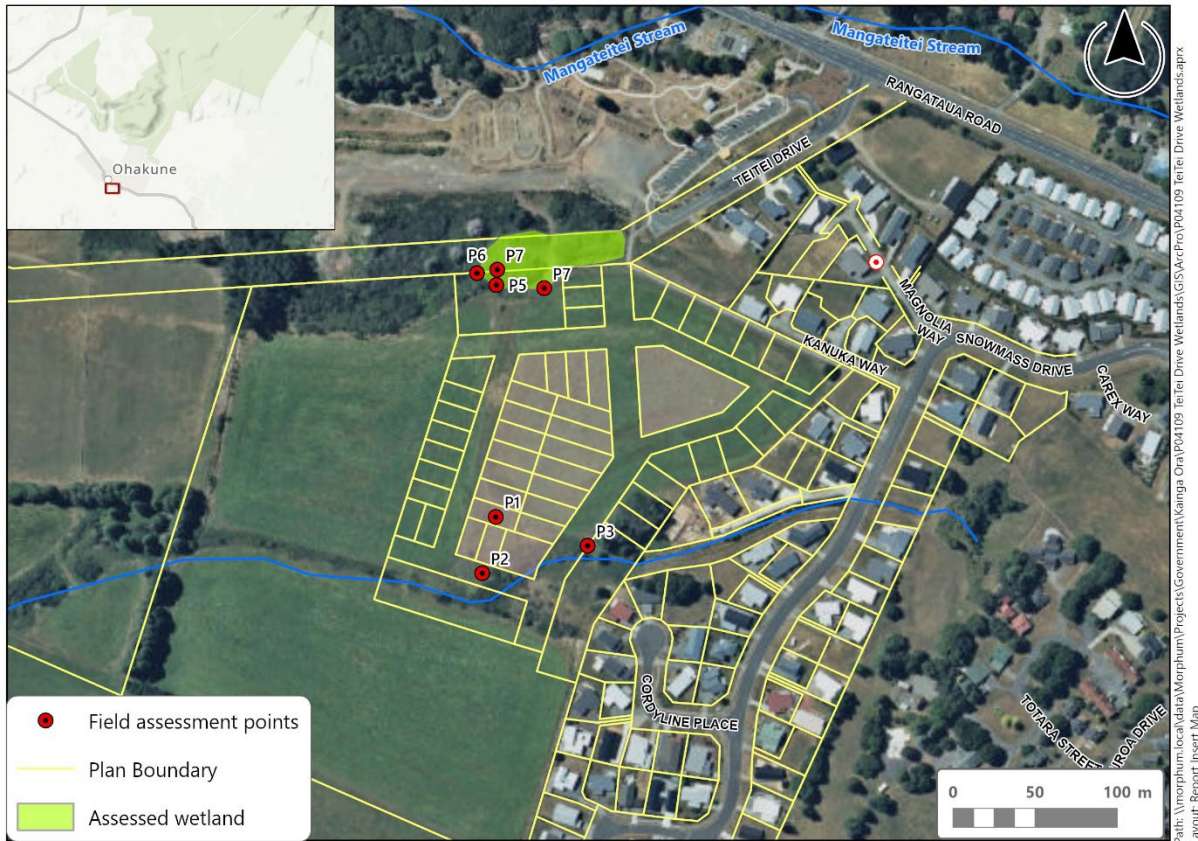
The assessed wetland extent on the site is presented below in Figure 4 along with the field assessment points.

**Figure 4: Assessed wetland area on site and location of assessment points**

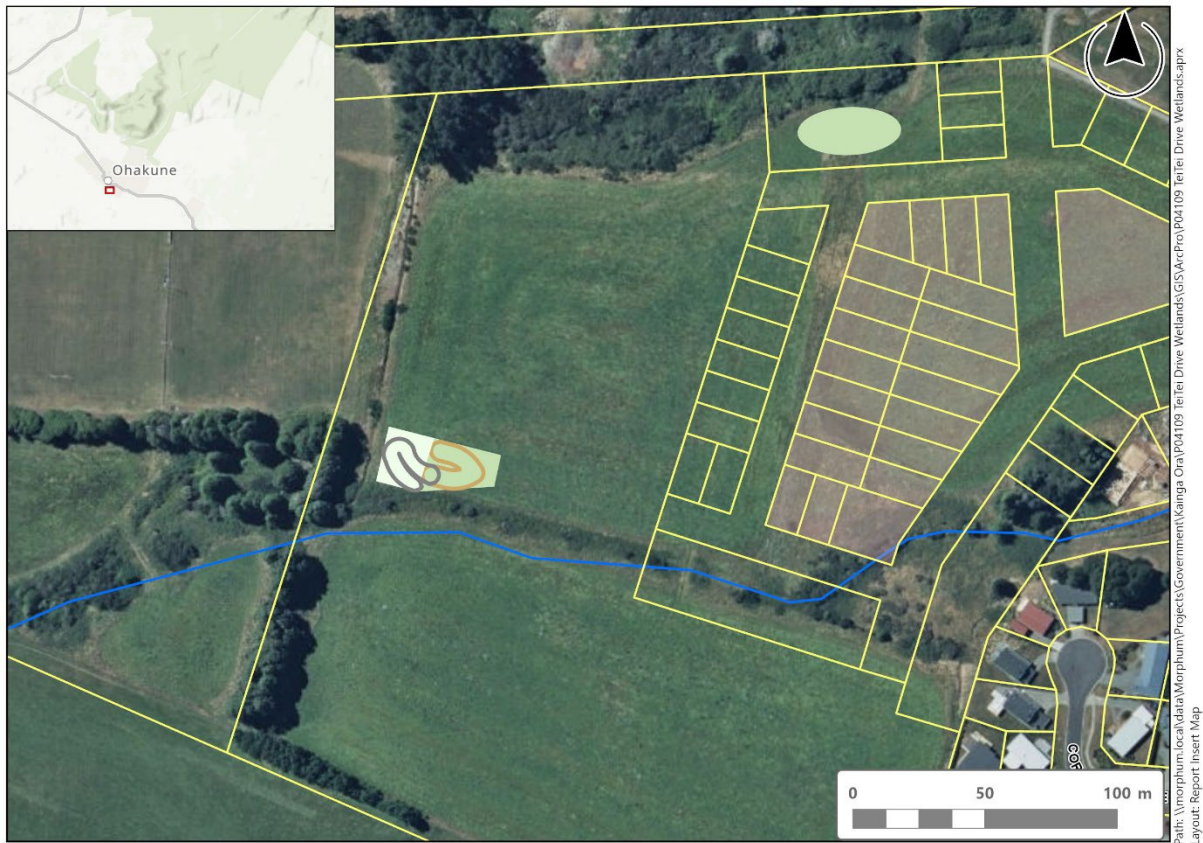
Potential opportunities for a scalable (stage 1 and 2) stormwater treatment wetlands is proposed in the south west of the site (the lighter shaded section would be to address stage 2. There is also potential for a water quality wetland in the north of the site. These are illustrated for concept only and are not to scale.

**Figure 5: Potential opportunities for the location of a scalable stormwater treatment wetland in the southwest of the site and a smaller stormwater wetland in the north.**

- Convey Road and Private Driveway runoff to a designed constructed wetland in the south west corner integrated with flood detention. The design of this will be critical to ensure the outcomes are achieved in a resilient and efficient manner requiring the following;

- Design in collaboration with landscape architects;
  - Design to enable staging of development;
  - Design to be offline to peak flows with hydraulics to control detention engagement for large infrequent flood events.
