PRELIMINARY ARBORICULTURAL & VEGETATION ASSESSMENT – TEITEI DRIVE BLOCK, OHAKUNE

PREPARED FOR: Kainga Ora – attn: Fletcher Wilson
BY: Richard Peers
DATE: 5 March 2023

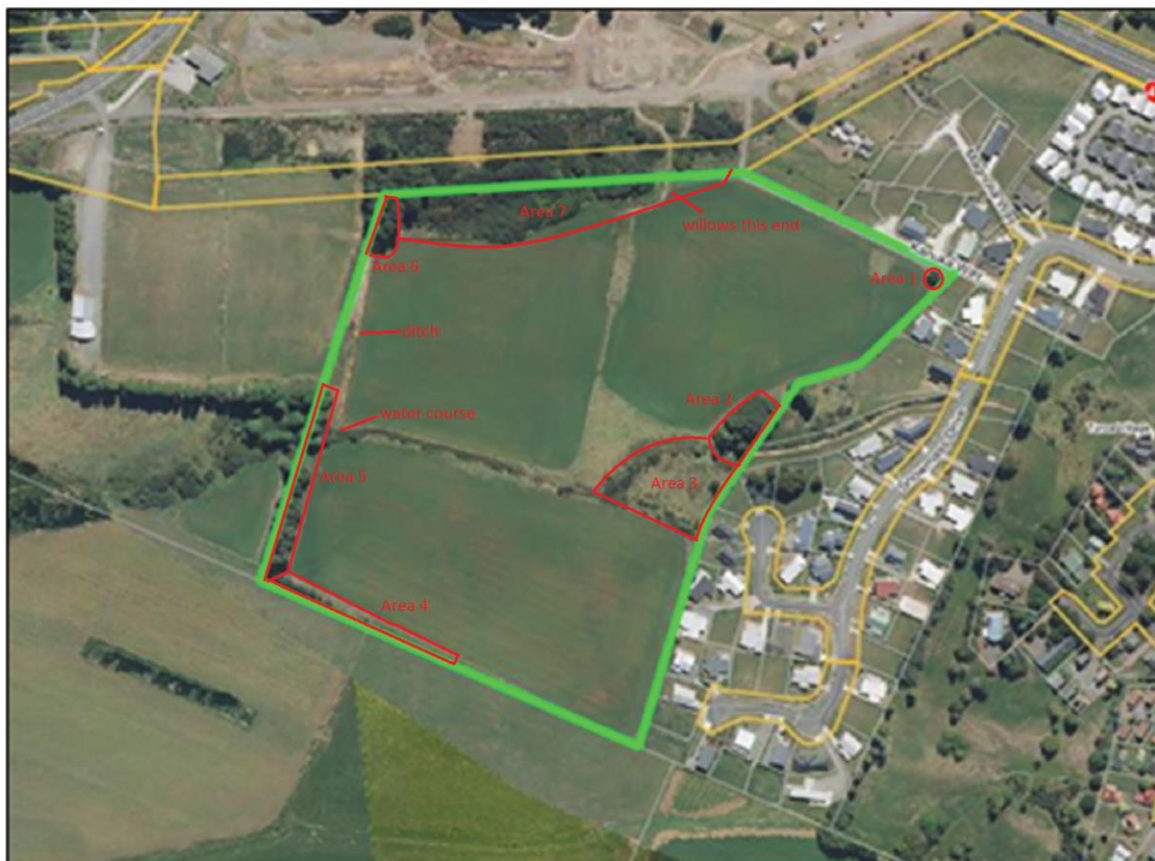
Appendix 1 – Area Plan

I have prepared a version of Photo 1 on which I have identified seven discrete areas of vegetation that are described in this report. There are also some notes on the map pointing out salient detail. The marked-up map is included as Appendix 1 to this report – and is also provided as an email attachment.
